**Bosque Ecosystem Monitoring Program –**

**Vegetation Monitoring 2007**

## **BEMP 2007 Vegetation Transect Summary Report**

January 22, 2008

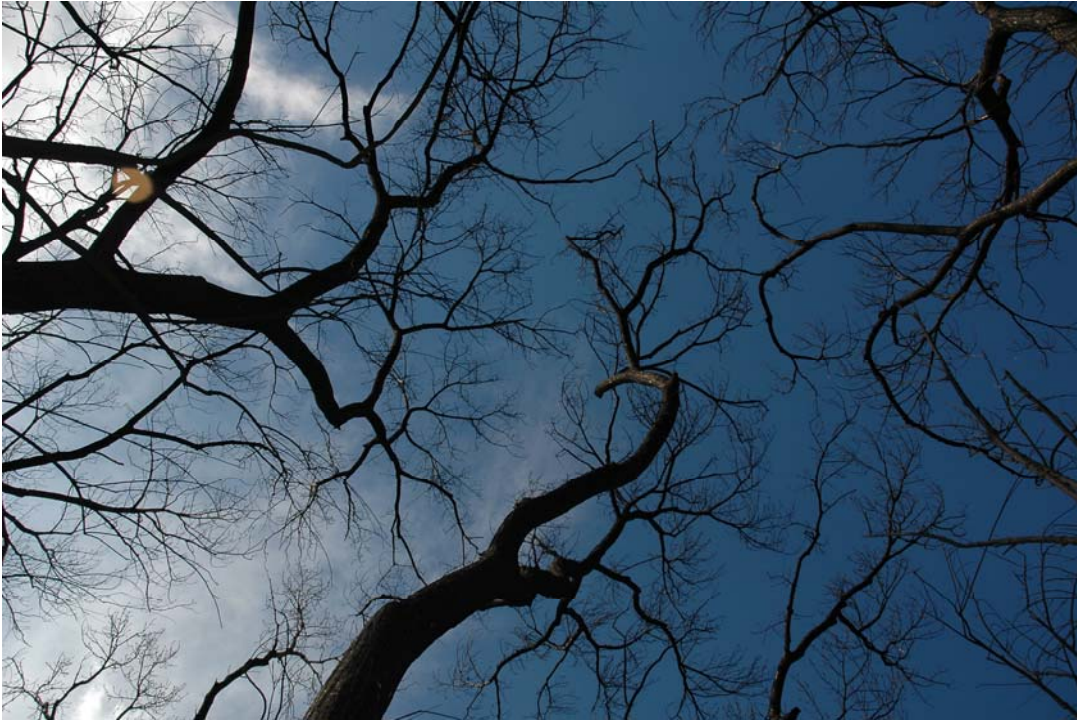
Charred cottonwood branches following a crown fire in the Valencia Forest BEMP site.

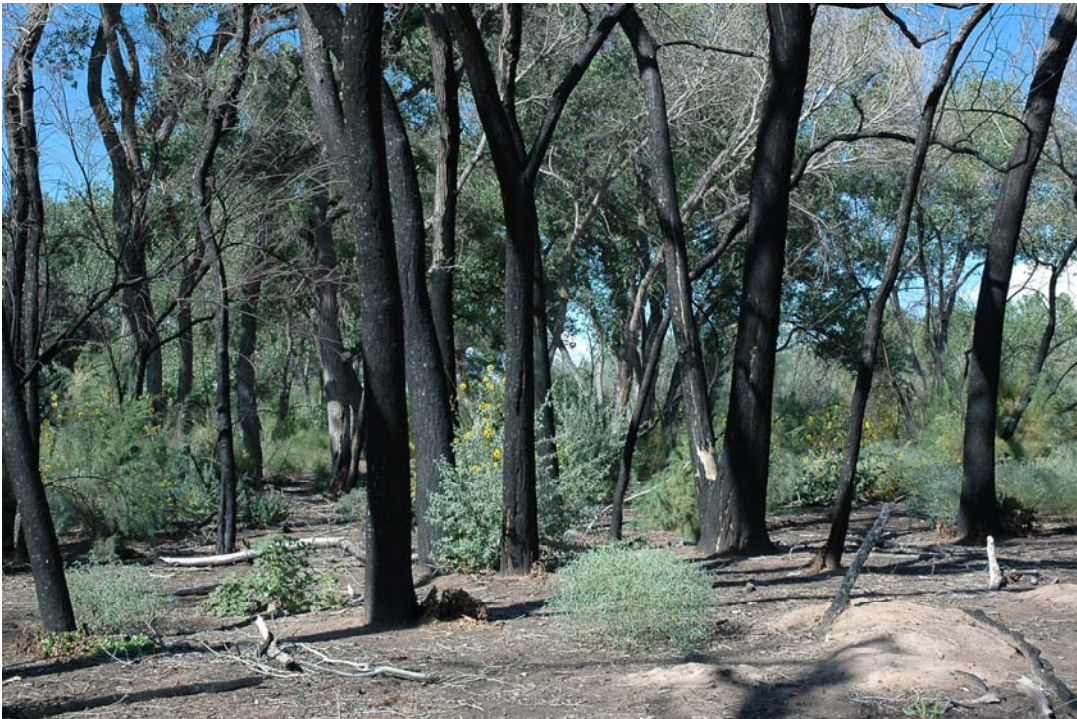
Scorched cottonwood trunks in foreground (Valencia Forest) contrast with unburned trees in the background (Valencia Cleared).

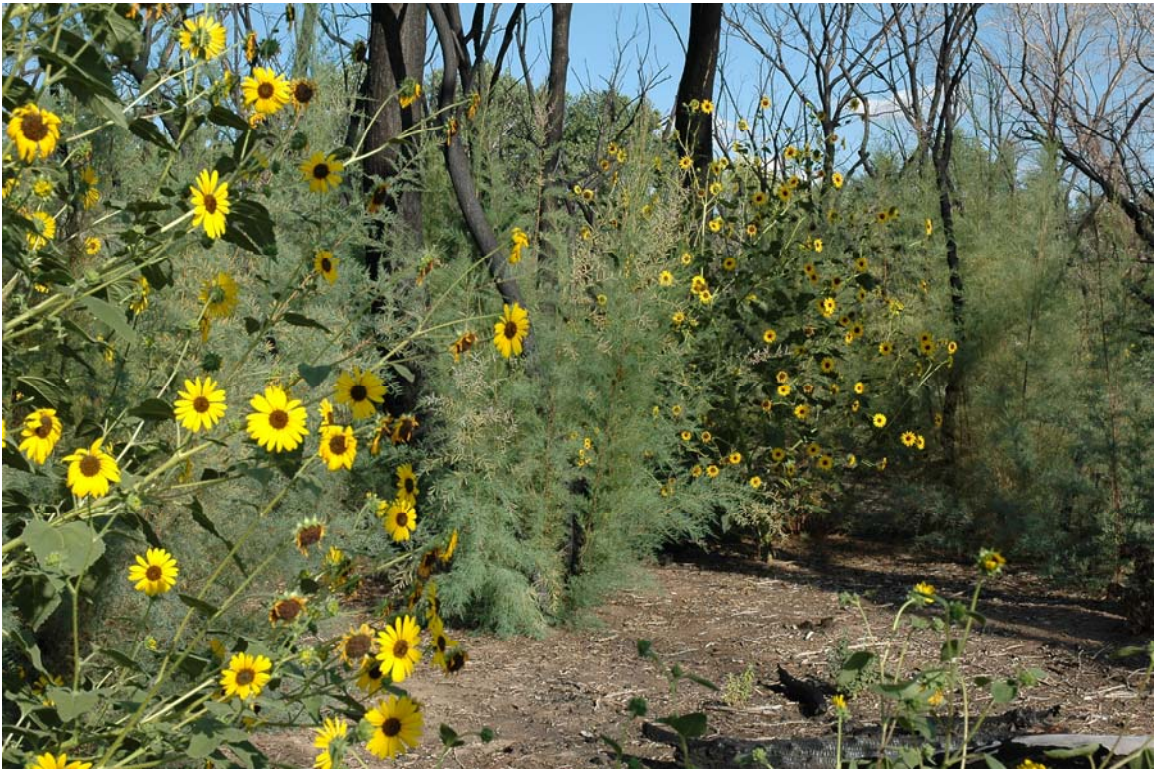
Valencia Forest - dead cottonwood trunks, sunflowers and resprouting salt cedar.

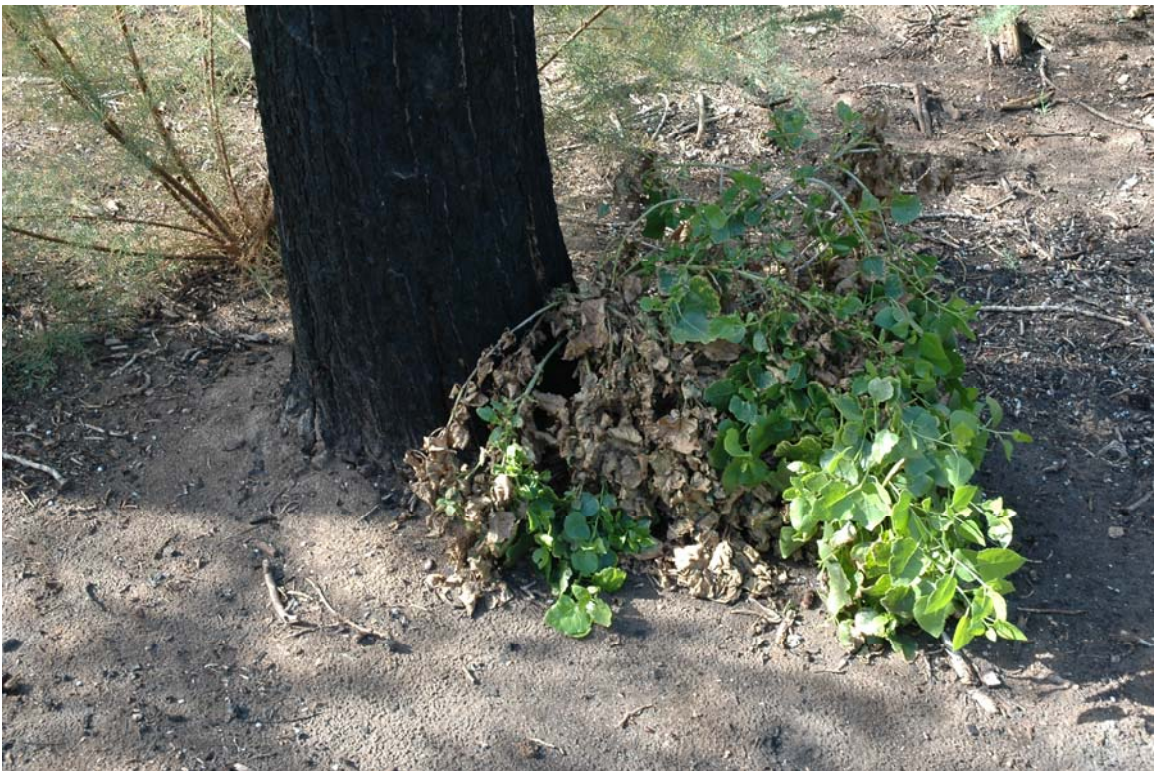
Valencia Forest - Large cottonwood resprouting from base. Sprouts appear stressed and unhealthy. Large-diameter trees appear less likely to resprout successfully than young trees.

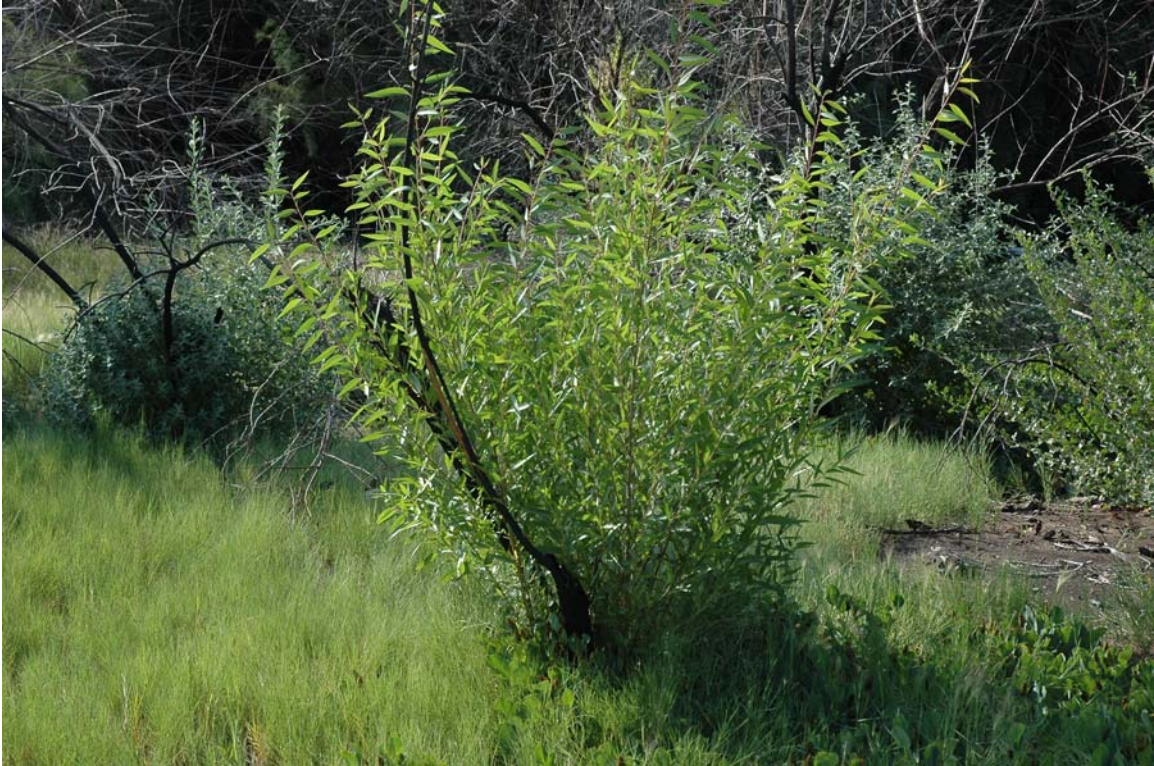
Gooding's willow and Russian olive resprouting vigorously above expanding grasses in Valencia Forest.

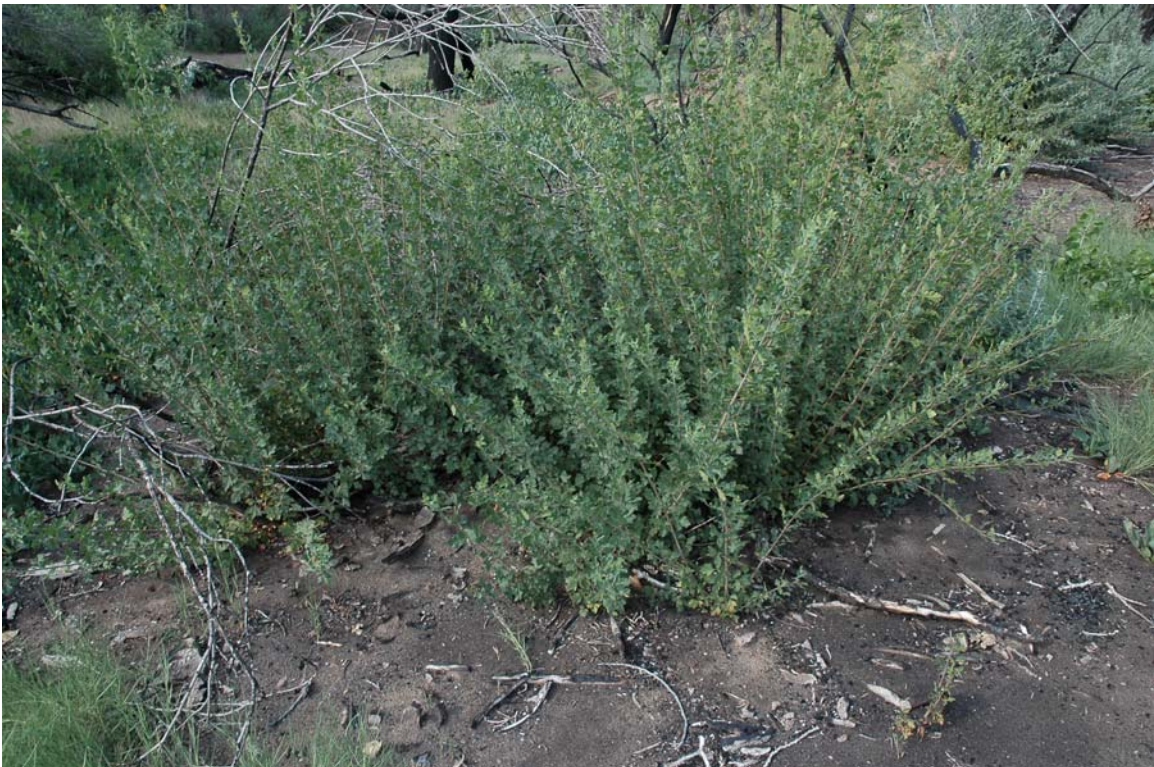
Three-leaf sumac resprouting in Valencia Forest.

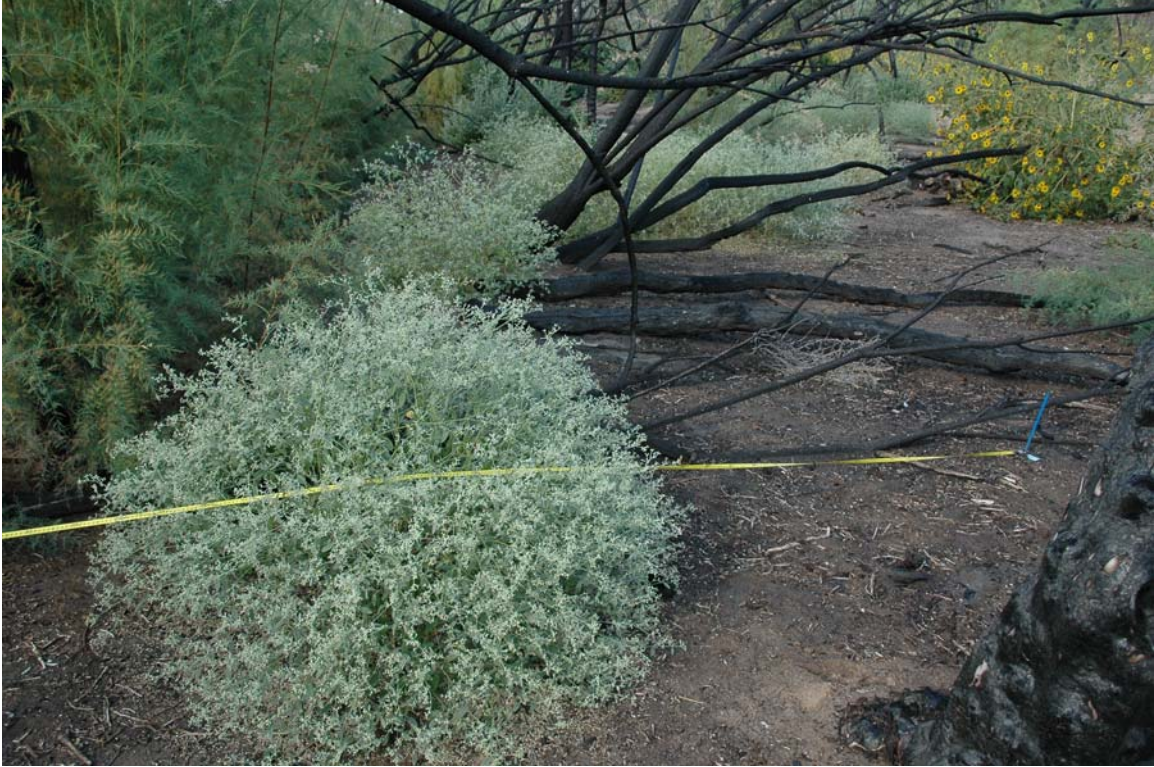
Texas croton thrives in post-fire Valencia Forest site.

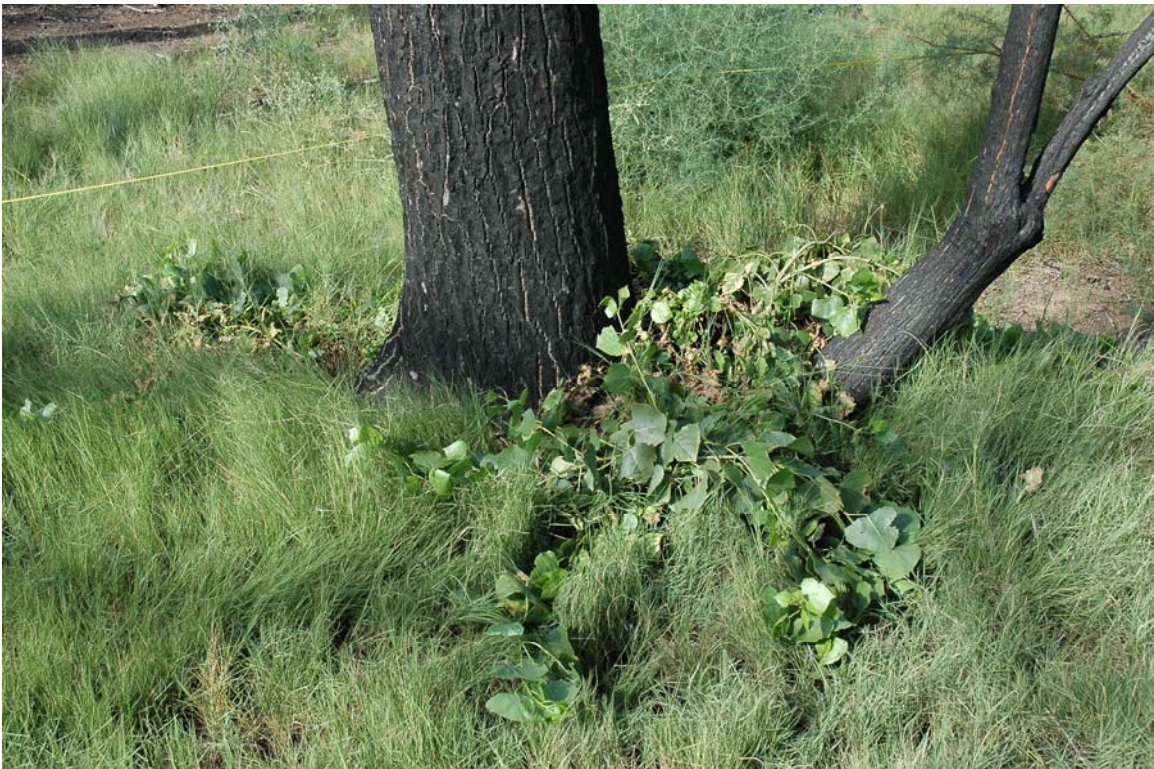
*Muhlenbergia asperifolia* and *Distichlis spicata* take advantage of areas opened up by the fire at Valencia Forest.

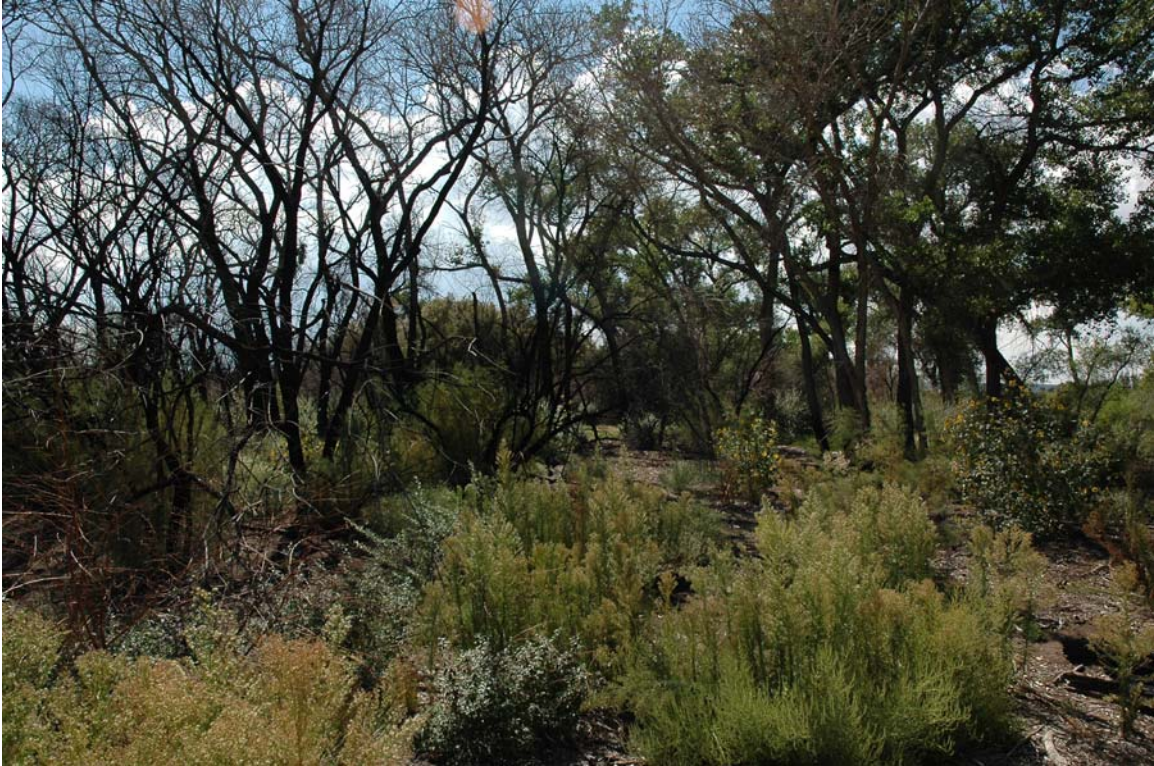
The fire burned hot in Valencia Forest (left) but left most of Valencia Cleared unburned (right).

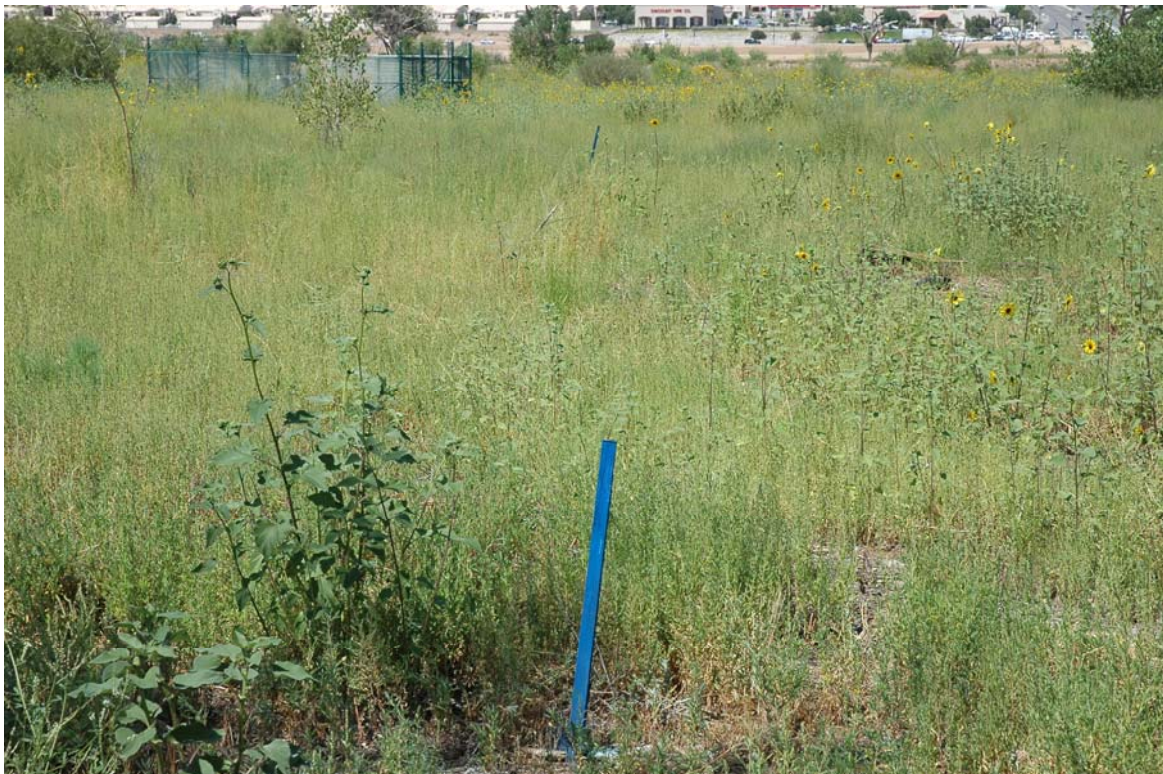
Montano, Line B. Transects are visible and avoidable by Open Space mower operators due to the tall painted wooden lathe marking transect ends. Low sunk rebar (not visible in photo) marks the line below blade height. This combination has survived several mowings while rebar alone is often thrown and bent.

Mowing at Montano presents a number of challenges. Our suggestion would be to use two markers for each corner of a vegetation plot. The rebar should be driven down until only four inches are above ground so as to avoid mower blades. The second marker could be a tall wooden lathe easily visible to BEMP staff and mower operators. As it is, tall exposed rebar gets thrown by mower blades and must be replaced. An example of a successfully double-marked line follows:
