# Double E Ranch Riparian Assessment

A Survey of Current Ecological Conditions  
to  
Support Resource Management Planning

Natural Heritage New Mexico Report – 15-GTR-390  
for  
New Mexico Department of Game and Fish

November 2015

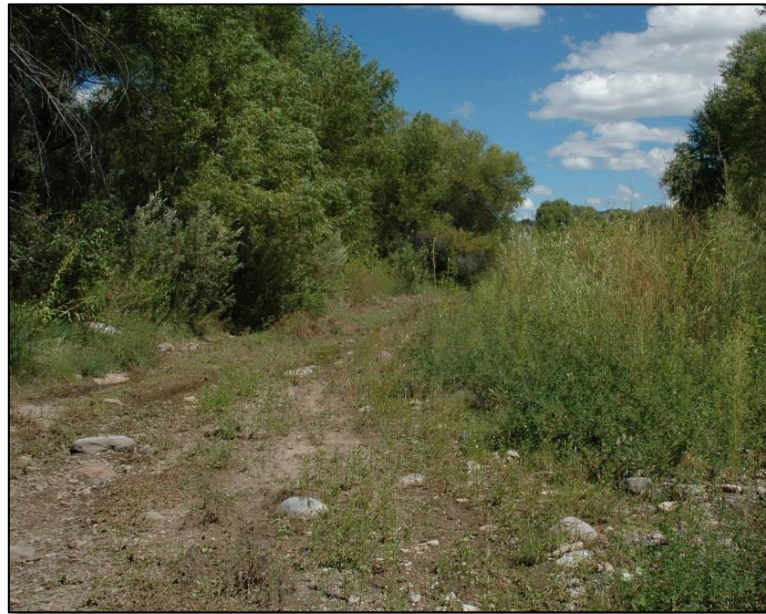
Figure 9. One of many places within the canyon where the road has been graded through the active river channel.

leveled either for use as home sites or fields, although all are now abandoned. The prior ranch owner graded a road through the riparian zone, following the canyon bottom, crossing Bear Creek multiple times from the western to the eastern boundary of the ranch (Fig. 9).

*Soil Surface Condition* is a measure of anthropogenic disturbance to the wetland and riparian soils which results in modification of soil characteristics. Disturbance to the soil can affect biological, physical and chemical processes and impede wetland function. All three SAs scored a Good rating on soil surface condition as a function of the dirt road graded into the river bottom by the prior owner (see Fig. 9). Outside of this, no other significant soil disturbances were observed.

The presence of the legacy road graded through the stream channel should be addressed. Maintaining this road and re-grading it is a threat not only to overall soil surface condition and erosion, but also through the alteration of channel geometry, which may impact hydrological connectivity, vegetation patch structure on adjacent bars and terraces, and surface water availability. In addition, road repair and traffic on the road could lead to direct impacts on habitats and individuals of federally listed species. Thus, we recommend that the road be decommissioned through active restoration or simply not be repaired, and that vehicle traffic of all kinds be limited and kept out of the active channel wherever possible.

2. Do not maintain the dirt road in the canyon bottom and develop a roadway restoration plan. As much as possible keep motorized vehicle traffic out of Bear Creek canyon, especially out of the active channel.

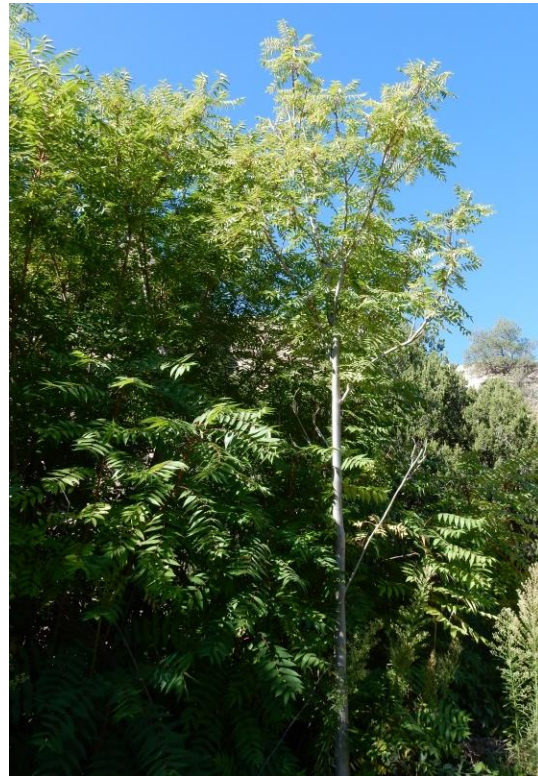
*Relative Native Plant Community Composition* is an index of the abundance of native-dominated versus exotic-dominated vegetation communities based on the most abundant species within each vegetation patch that was mapped. High native-plant species diversity generally indicates overall high biotic diversity, stability of wetland biotic communities, increased wildlife habitat and species diversity. The ranch received a Good score on relative native-plant community composition. There were large herbaceous patches dominated or co-dominated by exotic forbs and grasses. Woody dominants throughout the ranch were predominantly native, with the exception of one patch in the western SA dominated by tree of heaven (*Ailanthus altissima*), an introduced State listed noxious weed (Fig. 10).

Figure 10. Tree of heaven on the western SA.

herbicide, followed by mechanical removal, and repeated herbicide treatment on all resprouts.<sup>12</sup> We would recommend that the observed patches be treated to prevent their expansion and disruption of native habitat. We would also recommend a careful survey of the whole canyon for tree of heaven prior to treatment, to assure that all individuals are removed.

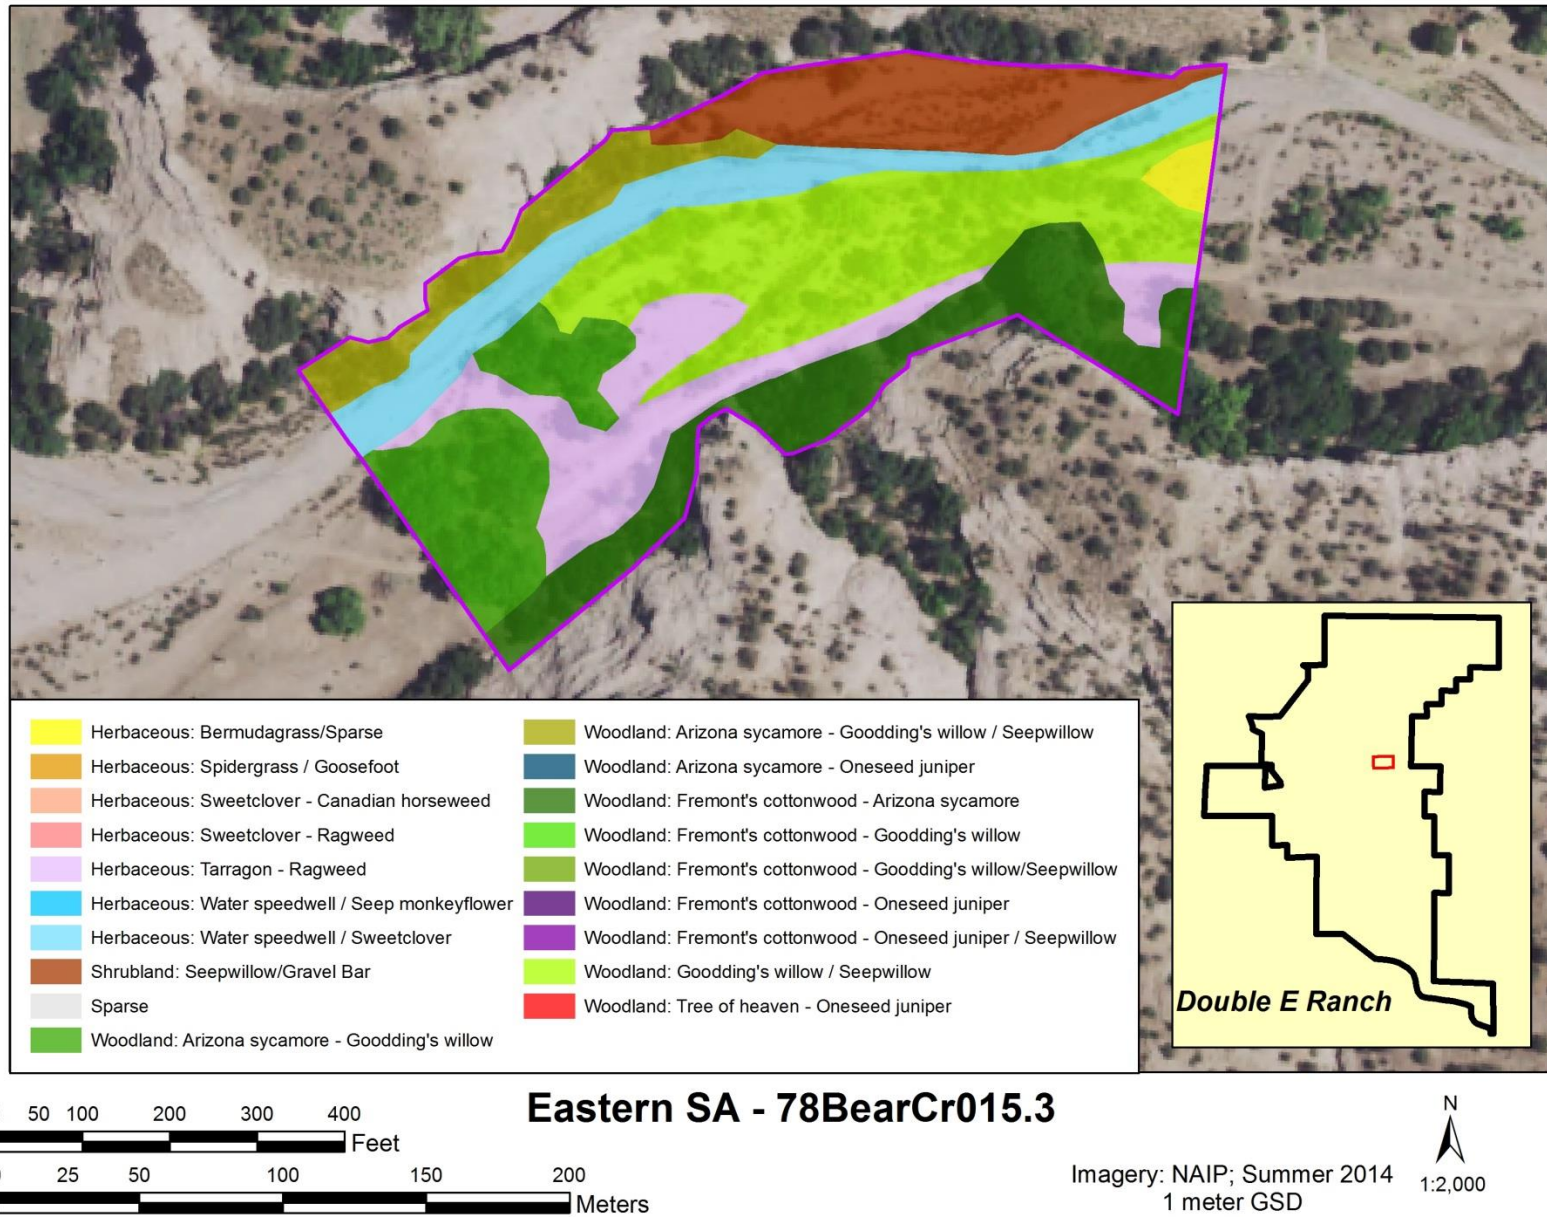
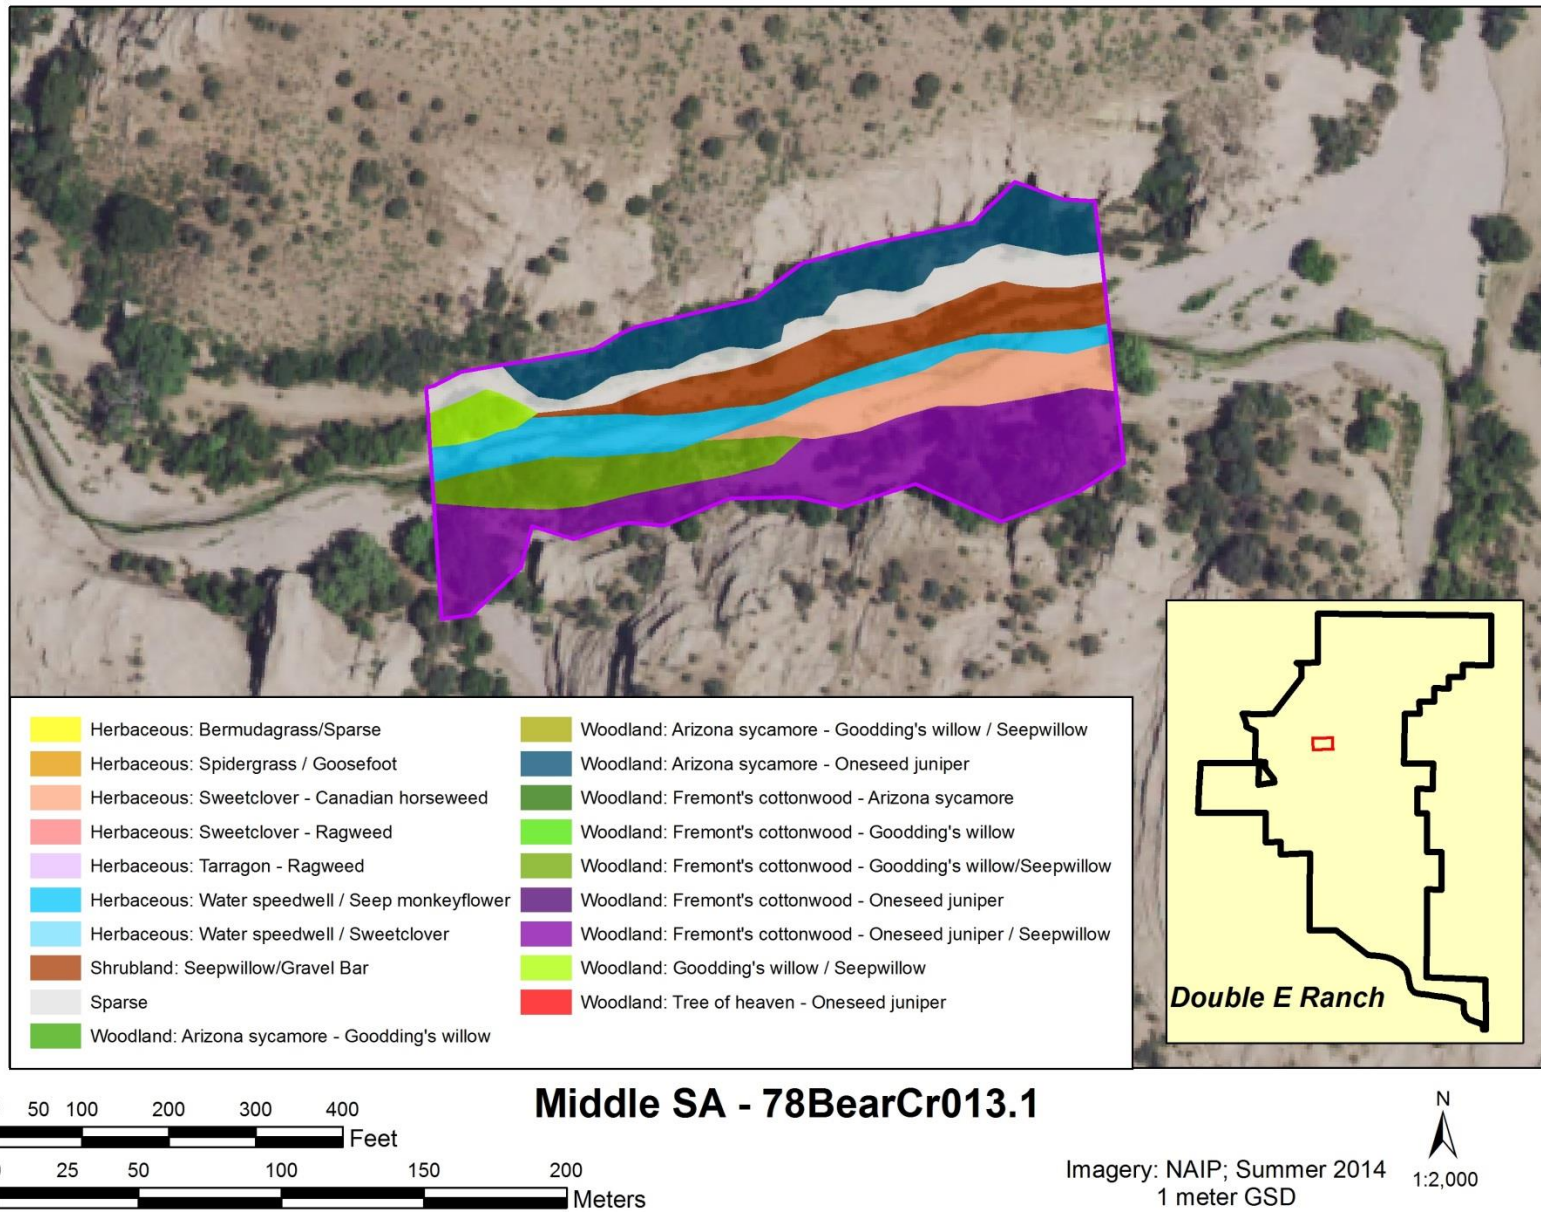
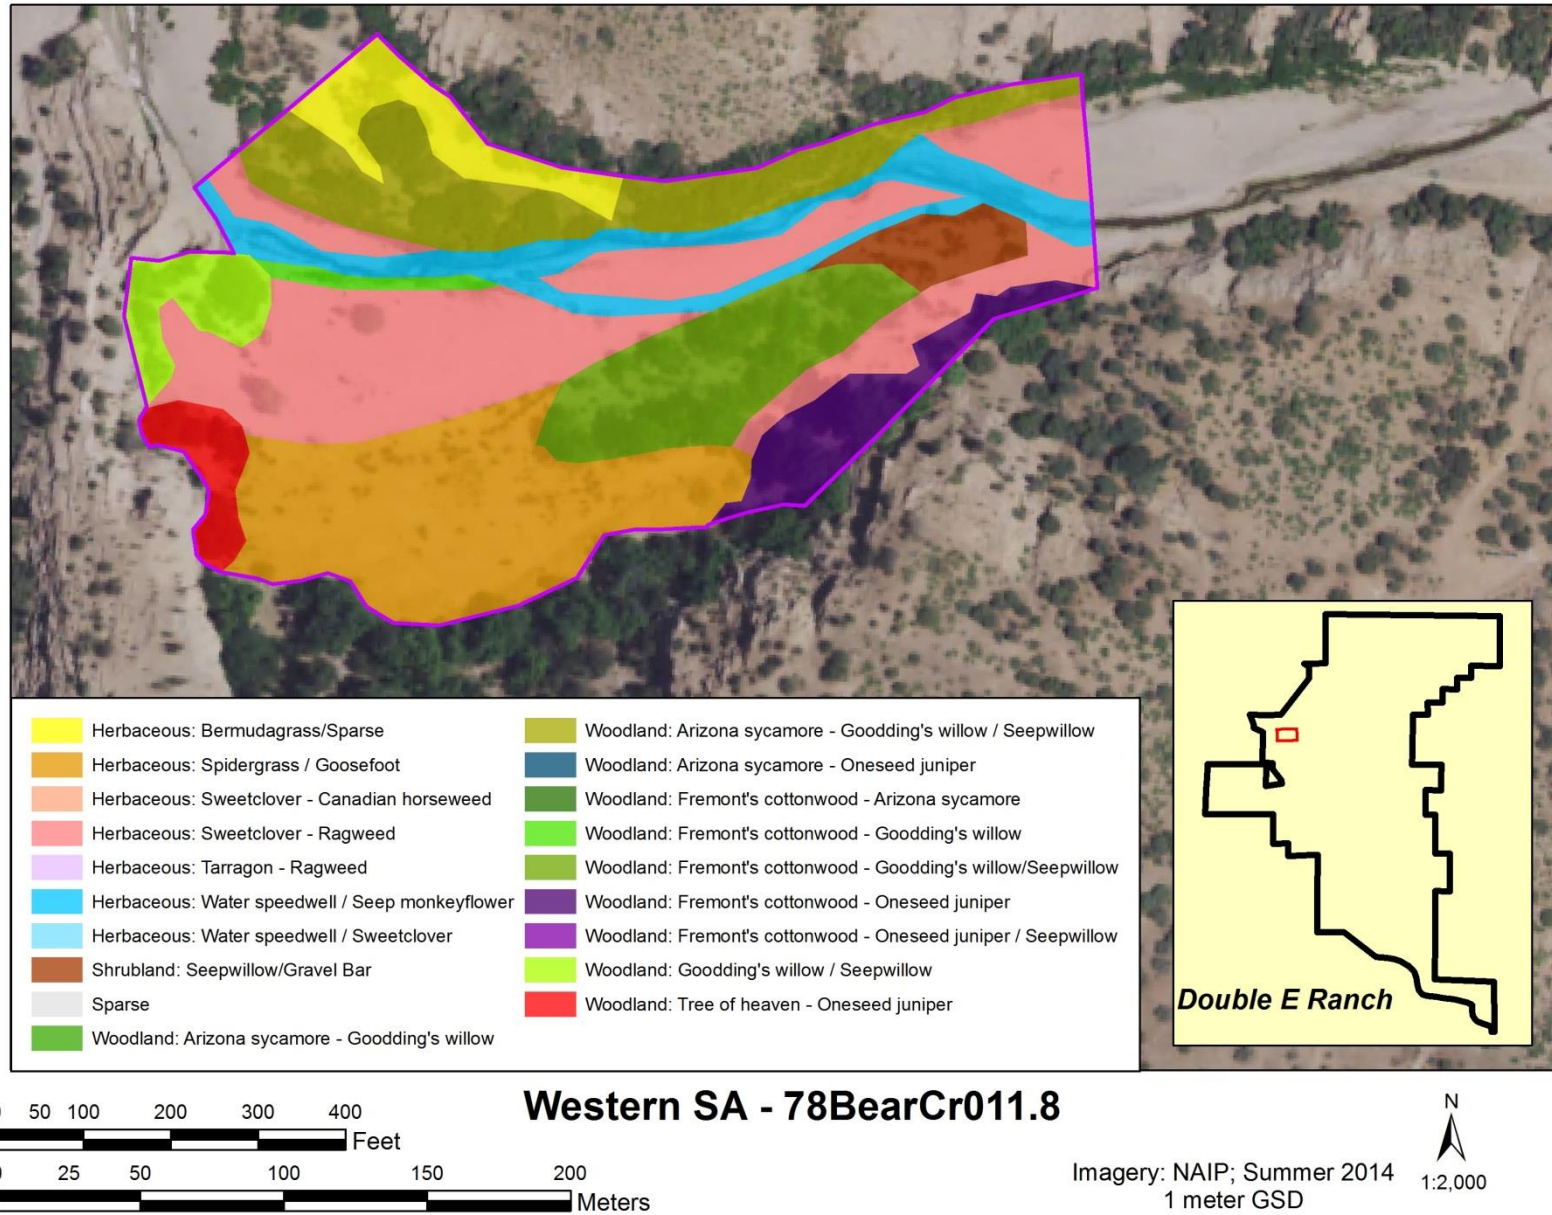
Biotic metrics measure key biological attributes within the wetland that reflect ecosystem integrity. These are primarily based on field mapping of vegetation communities (Figs. 11, 12, and 13)

*Vegetation Horizontal Patch Structure* is an assessment of general vegetation patch diversity and pattern complexity (interspersion) across an SA. Multiple plant patches that are more or less equally distributed across the SA indicate high biotic diversity and a history of dynamic fluvial processes. The ranch as a whole earned a Good rating on this metric. There was a moderate amount of different vegetation patches, but the amount of area per patch was often not equally distributed and interspersion of patches was low (i.e., patches were not highly intermixed) (see Figs. 11 and 12).

There were 19 different vegetation patch types mapped as part of the Biotic Metric data collection process (Figs. 11 to 13). These patches represent eight recognized plant communities and five provisional plant communities in the U.S. National Vegetation Classification<sup>11</sup> (Table 2). Although detailed community composition data was not collected as part of the NMRAM process, there is a wealth of published data available on the majority of the vegetation communities observed on the Double E Ranch. The ranch's forest communities, dominated by Fremont's cottonwood, Arizona sycamore and Goodding's willow, are all considered globally rare and highly threatened due to altered hydrologic regimes, flood control structures, and land conversion.
