# River Ranch Riparian Assessment

A Survey of Current Ecological Conditions  
to  
Support Resource Management Planning

Natural Heritage New Mexico Report – 15-GTR-388  
For  
New Mexico Department of Game and Fish

June 2015

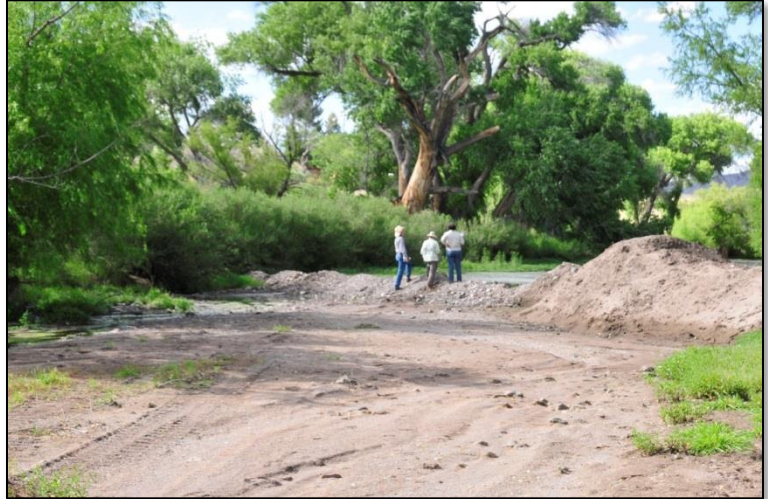
Figure 10. Earthen irrigation dam in the river channel looking upstream and north.

dam, and filled the ditch headgate with sediment.<sup>8</sup> This dam was diverting about 80% of the base flow when the site was visited in May 2015. The dam diverts water into an irrigation ditch that runs along the eastern side of the floodplain. In May 2015, the water was being returned to the river via overland flow just above the lower ranch boundary. The ditch continues south along the edge of the floodplain to actively cultivated fields below the property boundary.

1. Maintain maximum possible base flows in the active river channel, particularly in the growing season, and in keeping with the property water rights. If possible this should include a redesign of the irrigation dam, and active flow in the irrigation ditch only when needed for downstream irrigation.

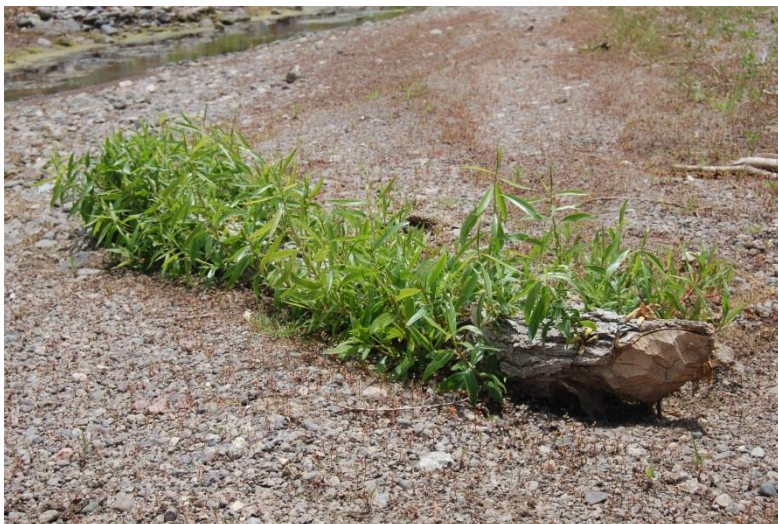
Native Riparian Tree Regeneration assesses the abundance of riparian tree reproduction across the SA. Healthy functioning riverine wetlands should consist of a mosaic of woody vegetation stands that include stands of both mature and young regeneration trees. Absence of young trees may indicate ecological dysfunction. The ranch earned a Poor rating on this metric, due to a near absence of native riparian tree reproduction. The upper and lower SAs did earn Fair ratings on this metric, but still had very little active tree reproduction. The majority of reproduction that was seen on the ranch was root, or adventitious shoots (Figure 11)

Figure 11. Gooding's willow branch in the active channel with adventitious shoots (Lower SA).

Almost no native riparian tree regeneration was observed during the sampling of the ranch. The reproduction that was observed was mostly sucker, or root sprouts (Figure 11). Only one seedling cottonwood was observed (on the lower SA), along with a handful of seedling walnut, soapberry and netleaf hackberry scattered across the ranch. There were also a handful of younger mature trees, but the majority the riparian trees on the ranch were old mature individuals. For germination, cottonwood and Goodding's willow need moist bare areas, generally fresh post-flood sediment splays. The areas need to maintain a high water table through the first growing season. Water should not recede faster than 3cm/day for optimal survival (Mahoney and Rood 1991). Finally, those areas of bare, moist ground must occur when seeds are dispersing in the spring. These riparian trees have evolved to take advantage of spring flood flows, and time seed dispersal relative to historic flood periods. The trees establish best at flood flows greater than or equal to seven-year return events (Stromberg 1993).

2. Livestock should be kept out of the active channel and adjacent riparian zone until the woody riparian vegetation has had a chance to reproduce and mature. Once vegetation has recovered, if grazing is considered, livestock use should be carefully monitored, and access to the active channel should be limited or excluded.

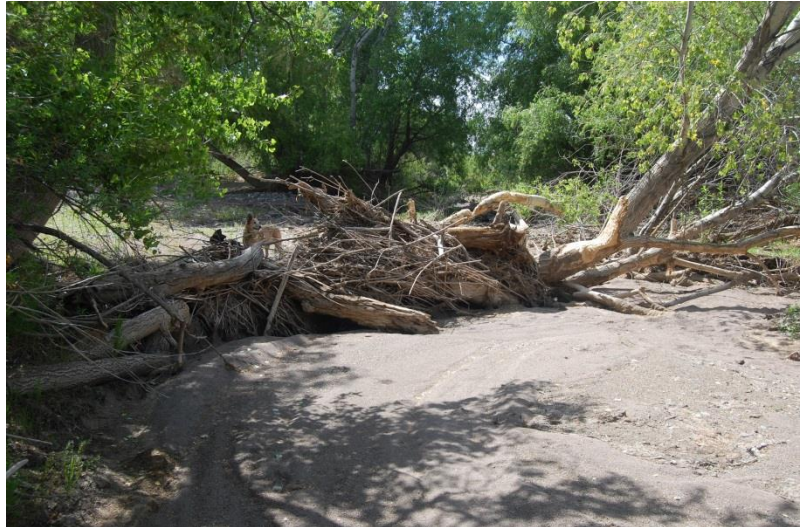
Figure 12. Fallen cottonwood blocking main channel on lower SA, beaver activity most likely occurred after the tree fell.

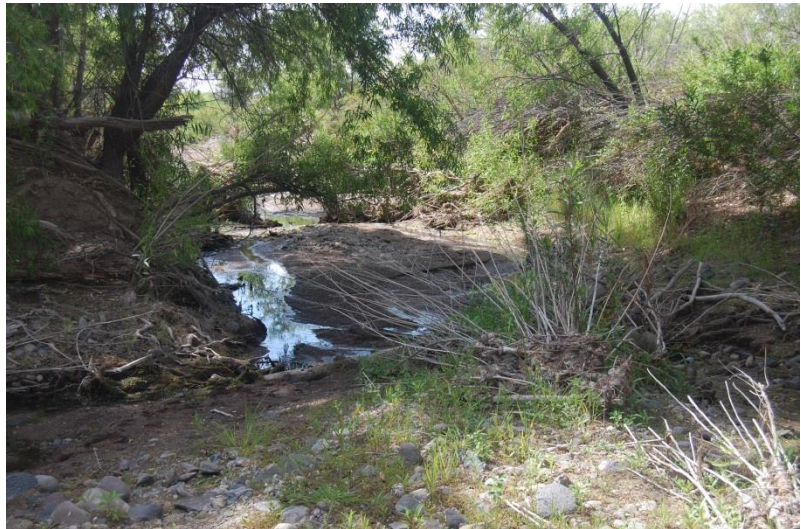
Figure 13. Head cut at top of new channel, just below fallen cottonwood (Figure 12).
