Long-term outcomes of a natural-processes approach to riparian restoration in a large regulated river: the Rio Grande Albuquerque Overbank Project after 16 years.

Running head: Natural-processes approach outcomes in riparian restoration.

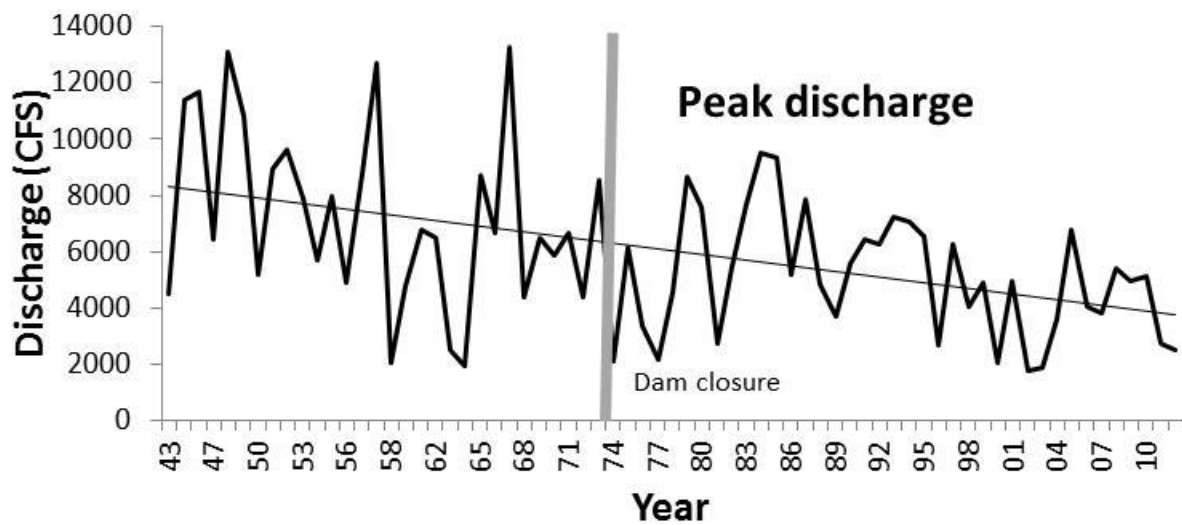
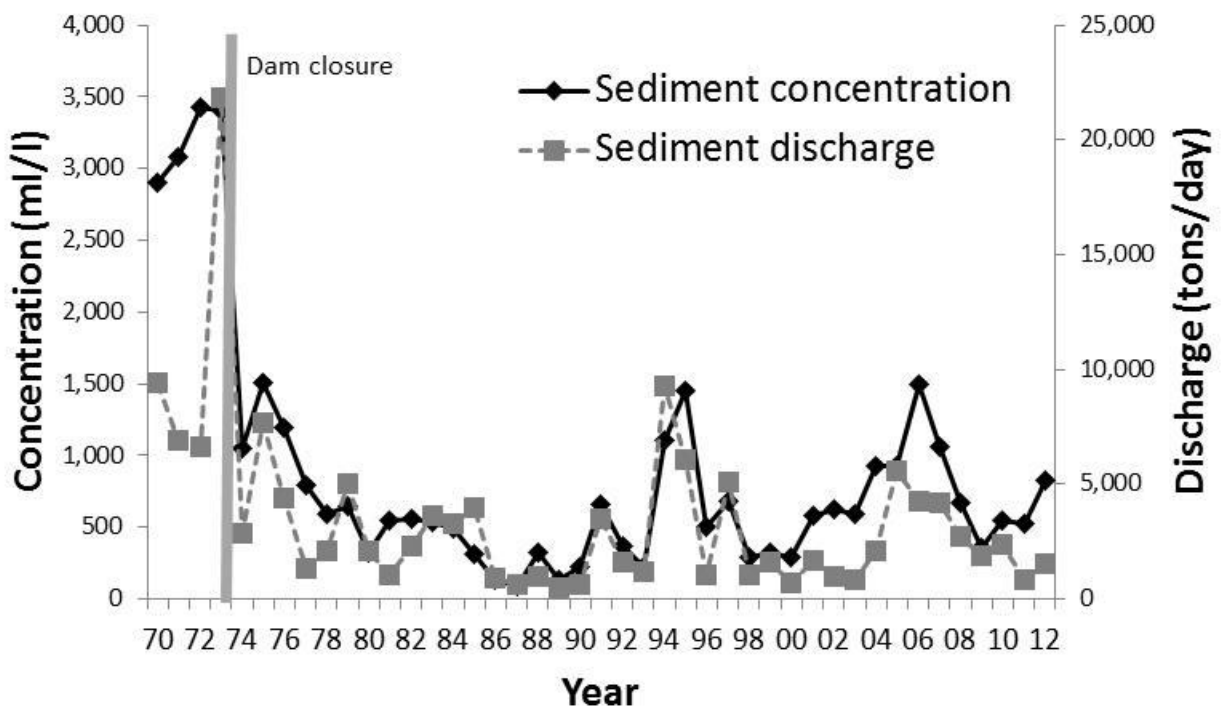
Figure 2. a) Annual peak discharges from 1943 to present at the Albuquerque gauge station (8330000), approximately 5 km (2 mi) upstream from the AOP site. Cochiti Dam was completed and closed in 1973 and peak discharges have declined since ($Y = -66.375x + 8363.1$, $R^2 = 0.2195$); b) sediment concentration and discharge since 1970 showing the steep declines since dam closure.

Hydrologically, Middle Rio Grande flows are determined by water passing through Cochiti Dam (approximately 50 km (30 mi) upstream), by discharges from a relatively small tributary (the perennial Jemez River), and by several large ephemeral washes that contribute sediment and water, primarily during the summer rainy season (see Fig. 4b). Flows in the Middle Rio Grande are also significantly affected by diversions for municipal drinking water and agriculture, but some of the diverted water may be returned to the river by agricultural drains and municipal waste water. With respect to the project period (1998-2013), river discharges were essentially normal in 1998 and 1999 with peak releases occurring in late spring following snowmelt and relatively steady summer base flows (see Fig. 4). But beginning in 2001, spring and summer releases began a downward trend in response to the regional drought conditions that continued through 2003. In 2004, spring runoff increased and peaked in 2005 along with good flows in 2007-08, but summer base flows remained low through 2013.

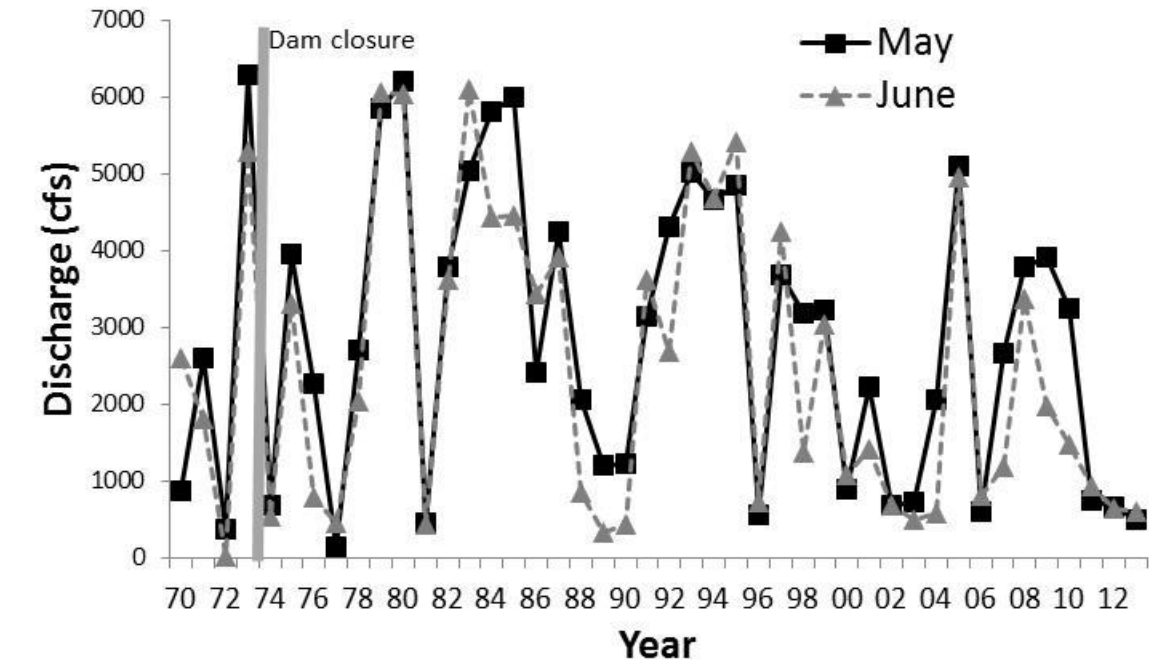
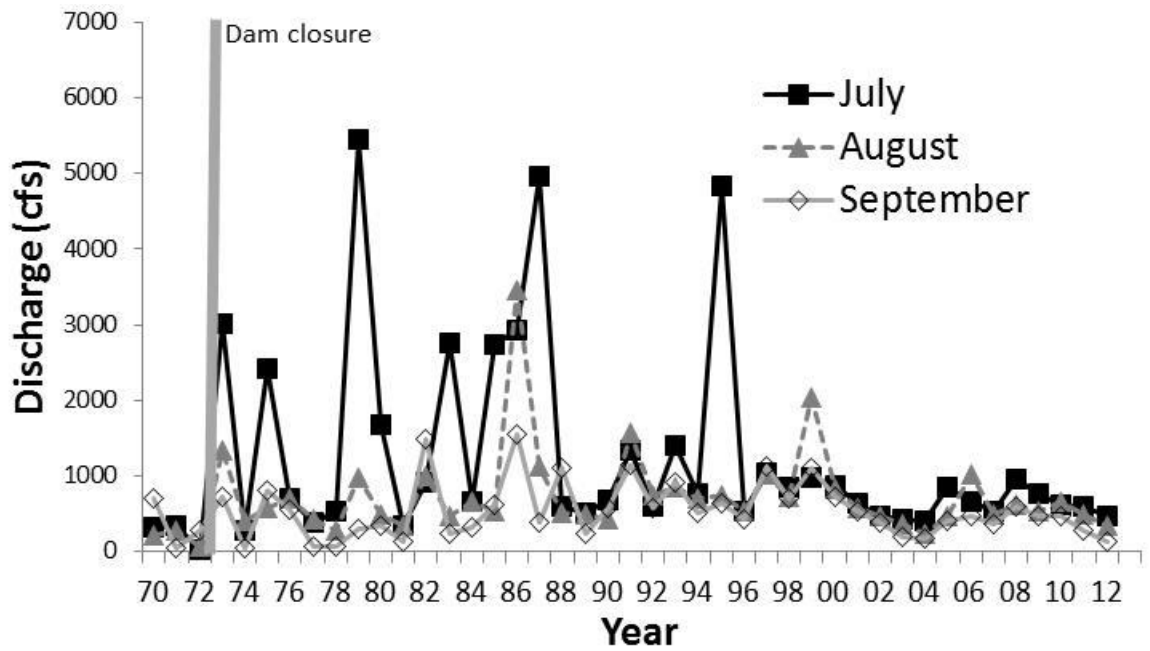
Figure 3. a) Average monthly spring-snowmelt period discharges in the months of May and June from 1970 to present; b) Average monthly discharges for the summer months of July, August and September from 1970 to present where flows are augmented by local monsoon thunderstorms (Albuquerque gauge station (8330000). Cochiti Dam was closed in 1973.

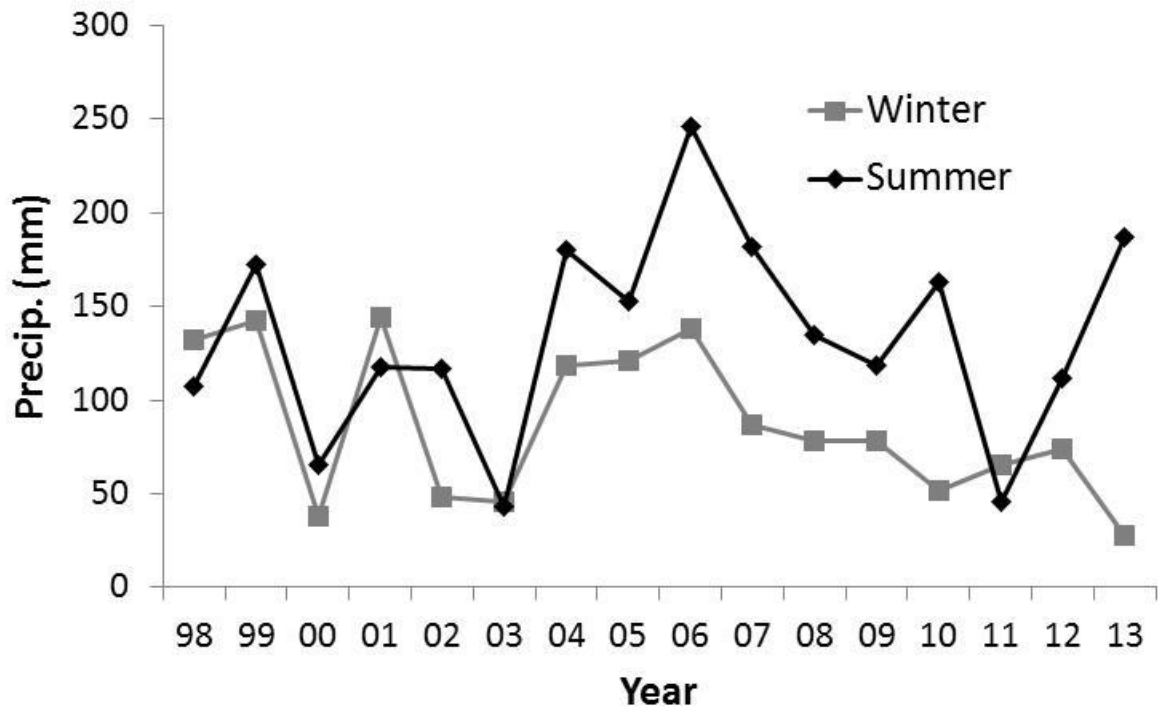
Figure 6. Mean summer (April-September) and winter (October-March) water-year precipitation as measured at the Albuquerque International Airport during the project period.

Climatically, the AOP site is located in a semi-arid zone where annual precipitation ranges from 83.5 mm to 403 mm (3.29 to 15.8 in) with a mean of 219 mm (8.67 in) as reported at the Albuquerque International Airport (290234), due east approximately 5 km (3 miles). About 50% of the precipitation arrives during the four-month summer "monsoon" season (June-September). Precipitation varied widely during the project period (Fig. 6). Key events were the above-normal summer amounts at the initiation of the project in 1998 and 1999, followed by exceptionally low amounts in 2000 and 2003 (the latter part of the region-wide extreme drought of 2002-03). Following 2003, the summer and winter precipitation was at or above normal (with the exception of 2011). In 2013, summer precipitation was above normal, but came late in the growing season, after our monitoring period.

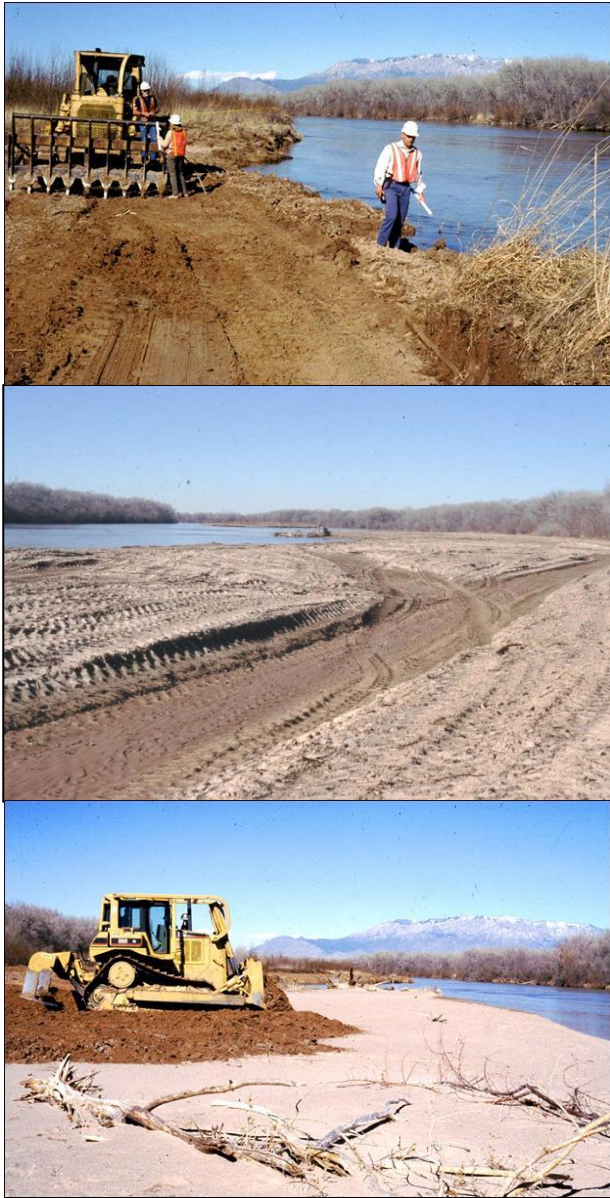
Figure 7. Mechanical manipulation on the AOP site prior to flooding: a) all introduced Russian olive was root plowed; b) the bar area adjacent to the river was lowered 0.6 m and channels and bars excavated; and c) the sediments from the lowering were deposited at the distal end of the bar.

In the winter of 1997-98, the stand on the southern end of the bar was mechanically removed by root plowing and the woody materials taken off site (Fig. 7). To set the stage for restart, a portion of the cleared bar was lowered sufficiently to allow overbank flooding during typical spring releases from the upstream dam. Side channels and small islands were engineered in the lowered bar to slow flood waters and aid sediment deposition, and to bring water to the back portion of the floodplain to create further complexity. Adjacent to and downstream of the lowered bar, an artificial bar at the same height was created from the fill from the lowering. In addition, where possible we left in place remnant, large woody debris (a few stumps and snags) to further aid sediment deposition.

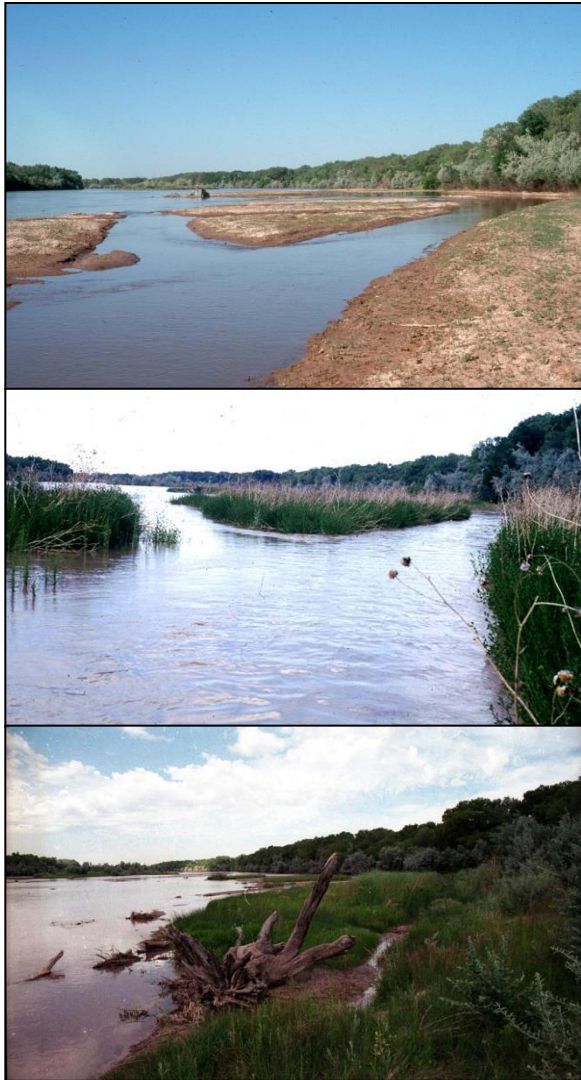
Figure 5. The spring flooding events in 1998 (a) and 1999 (b). The flood flows moved a large snag downstream to the south end of the restoration site where it became an anchor for sediment accumulation and new vegetation development (c). This area is referred to as the New Bar zone.

Overbank flooding across the lowered bar and bar fill zones occurred between 1998 and 2013, but the High Bar terrace was never flooded (although a lower depression along the northern edge became saturated at peak discharges). The first flood occurred from late May into early June 1998, with the peak discharge exceeding 4,000 cfs (113 cms) as measured at the Albuquerque gauge. Based on *post facto* backwater modeling of water and vegetation elevations, overbank flooding at the site likely occurred at between 2,750 and 3,000 cfs (79 and 85 cms). Regardless, this was below the design estimate of 5,000 cfs. The initial flooding lasted at least 10 days and inundated all of the constructed channel areas and bar surfaces (Fig. 8a). The site flooded again in 1999 on several occasions from late May into late June. By then, vegetation cover was already high enough to help stabilize the site and modify flood-water dispersal (Fig. 8b). There was no flooding in 2000, despite above-normal precipitation, but during the drought year of 2001, a two-day flood occurred in mid-May that inundated the entire constructed bar surface. Overbank flooding occurred again on the lowered bar in 2005, 2008, 2009, and 2010 leading to slow filling of the channel and buildup of the island bars plus extensive deposition at the distal end of the constructed back channel.

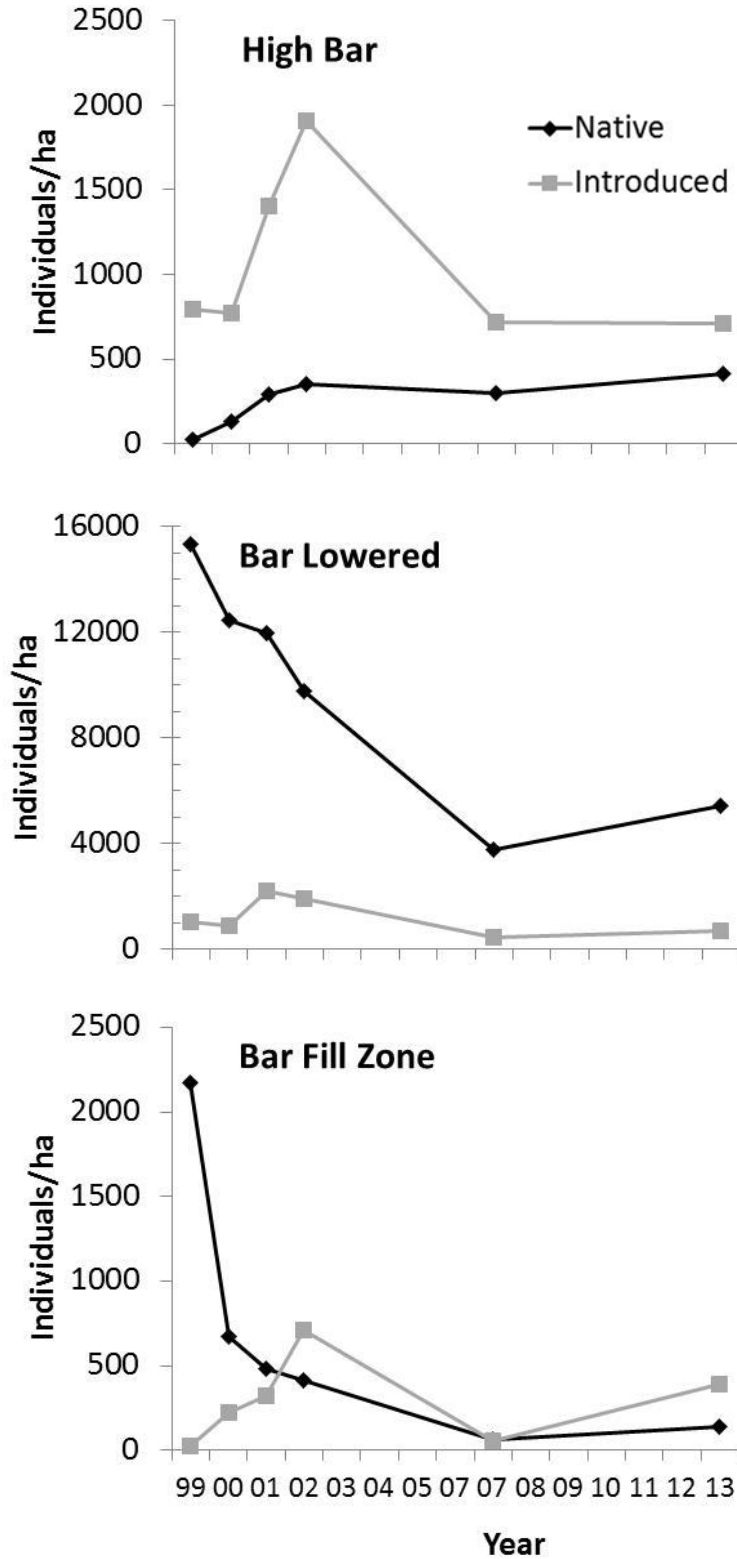
Figure 6. Mean yearly densities of native (mostly Rio Grande cottonwood) and introduced trees (mostly Russian olive) since the second growing season (1999) following manipulation (note: Y-axis scale differs between A, B and C). NEED TO LABEL GRAPHS A, B & C.

With the exception of the High Bar and Bar Fill zones, exotic-tree densities were significantly lower through time than native trees. The prevalence on the High Bar is attributed primarily to resprouting remnant roots, and this may be the case in the other zones as well. Russian olive was the most abundant, but saltcedar, mulberry (*Morus alba*), and Siberian elm were also present. Densities and sizes of individuals continued to increase through 2002, when numbers were then twice that of 1999. In the fifth year, 2003, and again in 2005 spot retreatments reduced the numbers down to approximately the 1999 level. Numbers have risen again since 2007, but at a slower rate, and in 2013 densities on the Lowered Bar and High Bar were still at only about 35% of their 2002 levels and 54% in the Bar Fill zone. Introduced species had made some headway on the New Bar sites (320/ha), but cottonwoods still outnumbered them at a ratio of 3.5:1.

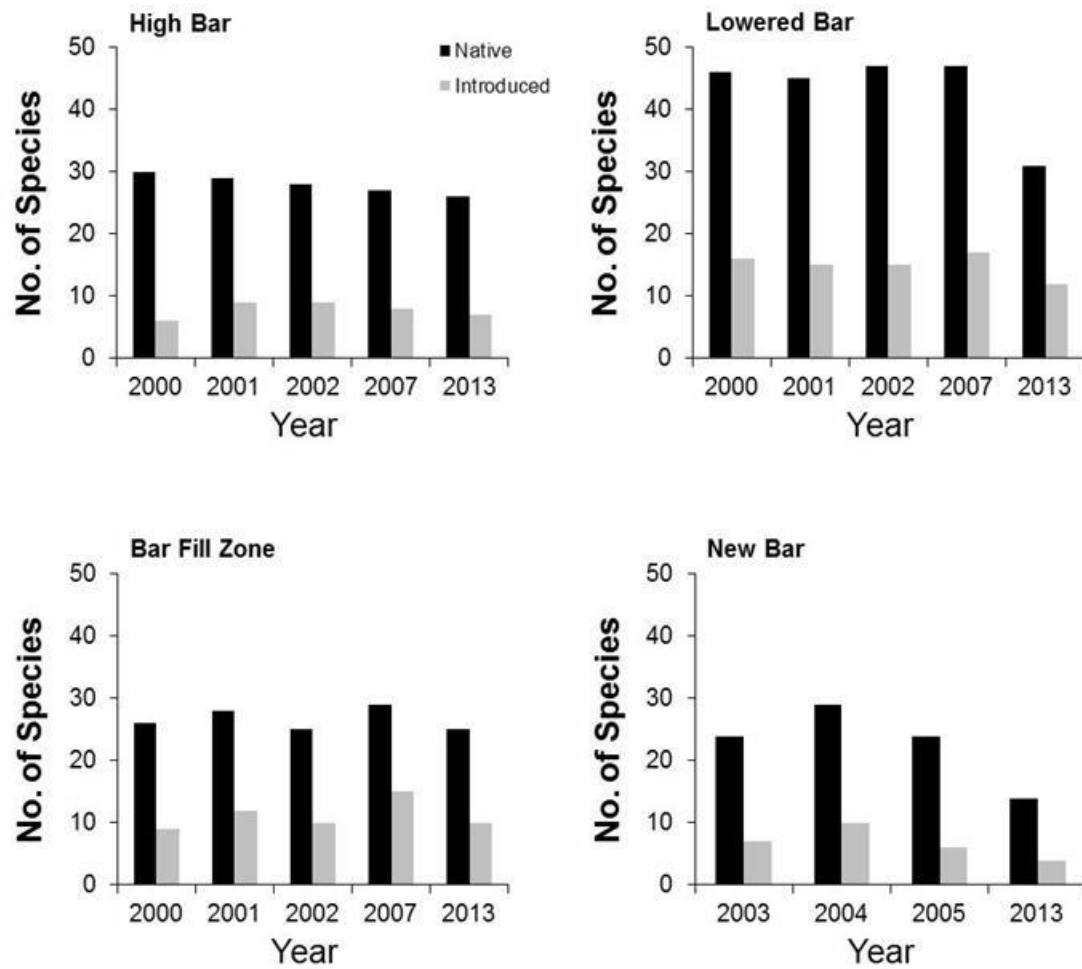
Figure 9. Native versus introduced plant species richness by sampling zone.

has shifted through time, cumulative native species richness has only continued to increase. By 2013, 148 native versus 26 introduced species had been recorded, and through the years the percentage of native species has remained more or less constant at about 85%. Overall, forbs accounted for about 50% of the species, followed by graminoids at 40%, with trees and shrubs making up the remainder. Native species richness was highest on the Lowered Bar with 40 or more species present in any given year except the drought year of 2013, and at about three times the number of introduced species (Fig 12). The other zones, while less rich, were still predominantly native in composition.

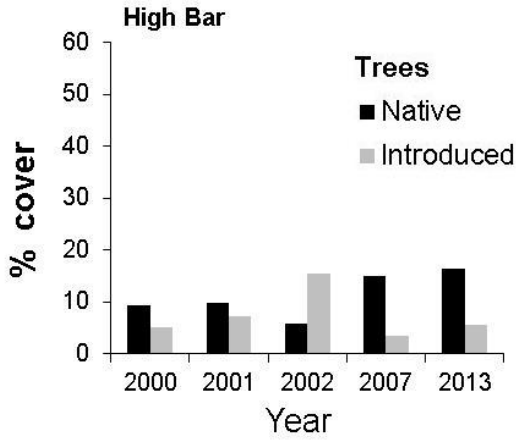
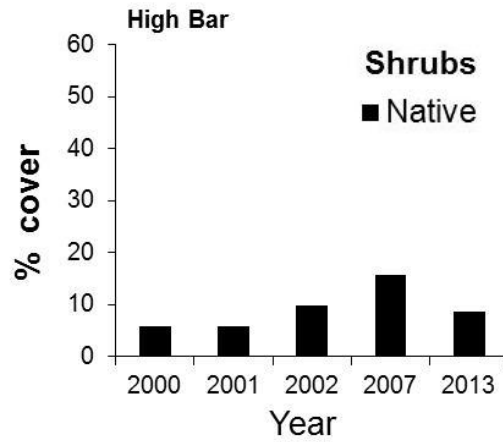
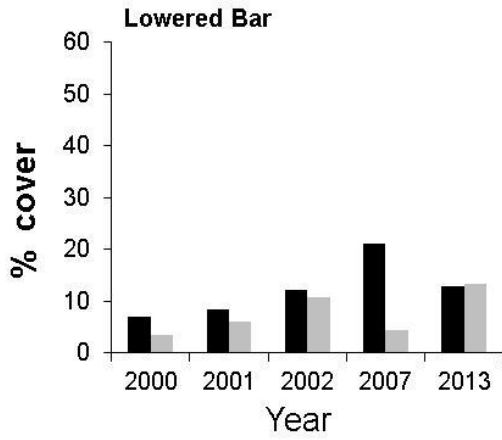
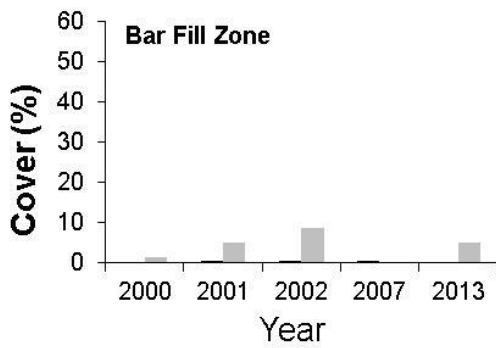
Figure 13. Percent canopy cover of native trees and shrubs by sampling zone (excluding the New Bar zone).

As with the trees, bar zones were important with respect to abundance of shrubs, grasses and forbs. Among shrubs, obligate and facultative wetland native species were the overwhelming dominants led by coyote willow (*Salix exigua*) and false willow (*Baccharis salicina*). They were particularly prevalent on the Lowered Bar, remembering that saltcedar and Russian olive were considered trees here (Fig. 13). Cover increased steadily, reaching a peak in 2007 and dipping in 2013. In the Bar Fill zone, cover also increased as coyote willow clones expanded from the bar edge into the main part of the zone.

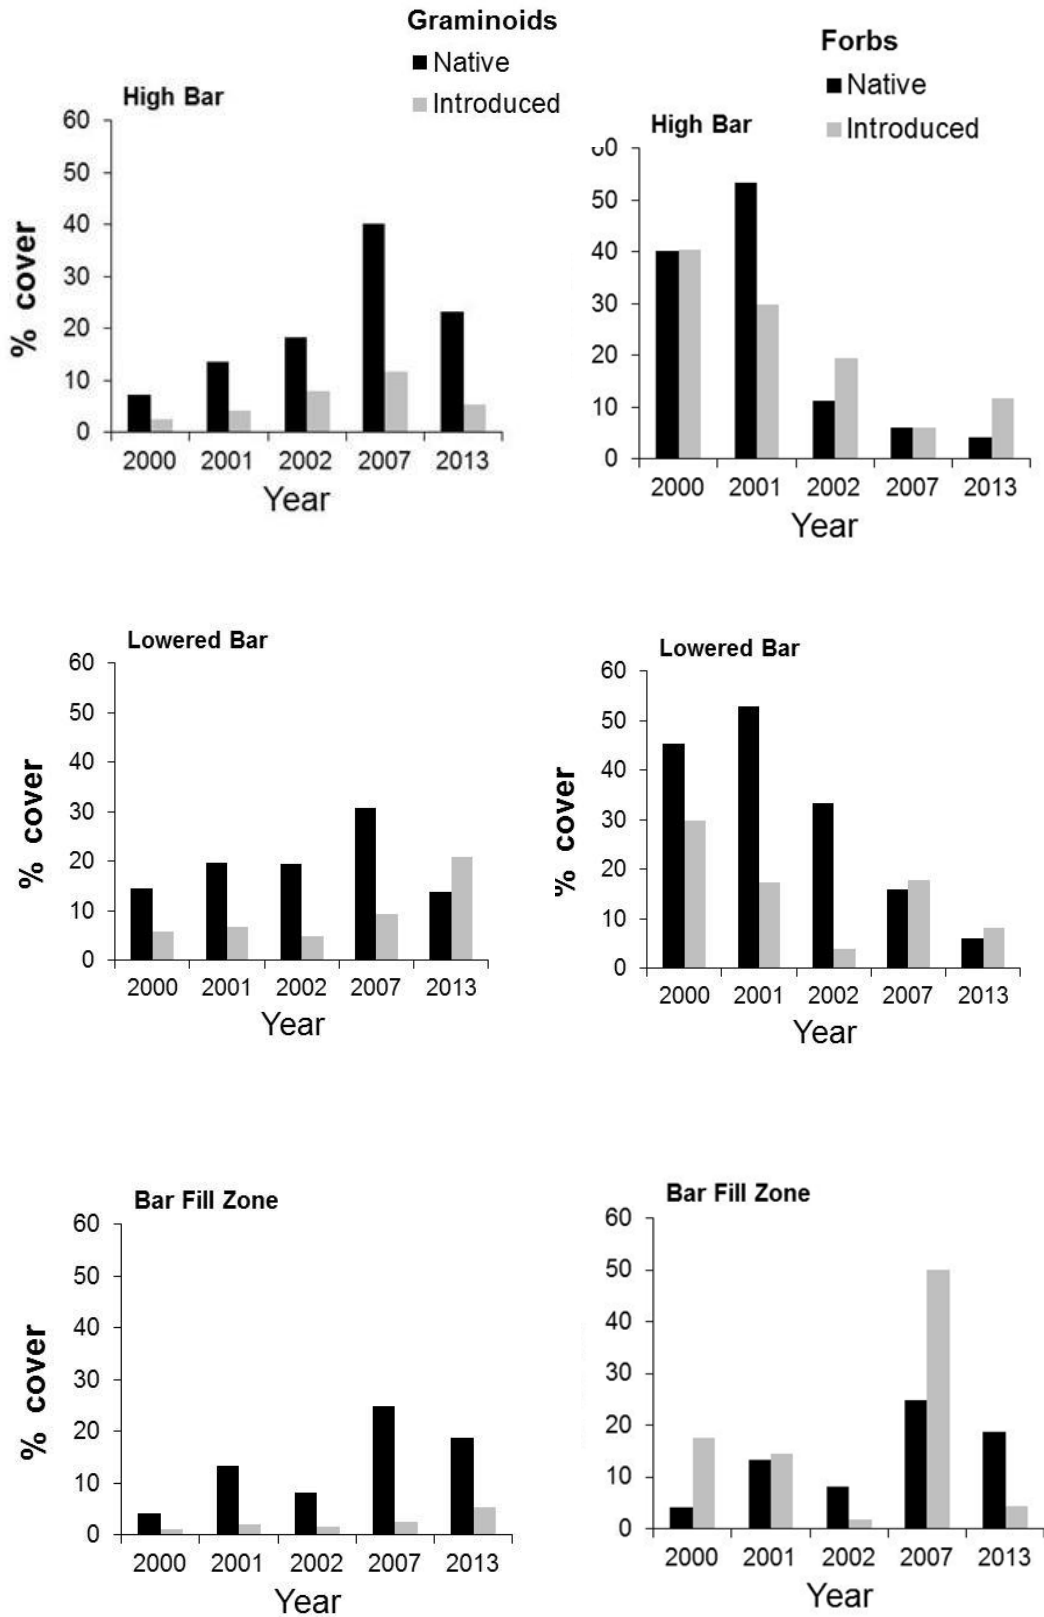
Figure 14. Graminoid and forb percent canopy cover of natives versus introduced species by sampling zone (excluding the New Bar zone).

Forbs were abundant in the early years on the High Bar and Lowered Bar but significantly dropped off in cover by 2007 and 2013 (Fig 14b). Native perennials in particular have declined since 2007, e.g., horseweed (*Conyza canadensis*), western goldenrod (*Euthamia occidentalis*), and Canada germander (*Teucrium canadense*) declined 50-90% depending on location. Some species, such as smooth horsetail (*Equisetum laevigatum*), a native facultative wetland species, increased in cover. Introduced perennials such as yellow sweetclover (*Melilotus officinalis*) and field bindweed (*Convolvulus arvensis*) were variable depending on year and sampling zone, but in general they also declined from 2007 onward. Annuals, as might be expected, were even more variable. For example, prairie sunflower (*Helianthus petiolaris*) dominated several sites in 2001, but was found as only scattered individuals in 2007 and beyond. Rough cocklebur (*Xanthium strumarium*) abundance peaked in 2002 but was nearly absent by 2007. Common ragweed (*Ambrosia psilostachya*) was abundant in both 2001 and 2002 and was still common in the High Bar zone in 2007, but uncommon elsewhere. Kochia (*Kochia scoparia*) and Prickly Russian thistle (*Salsola tragus*), both introduced annual species, reached peaks in cover in different places and times: 2002 on the High Bar (15%), and in the Fill Zone in 2007 (31%), but were non-factors in other zones and years. By 2013, native and introduced species cover was not significantly different on the High Bar and Lowered Bar sites

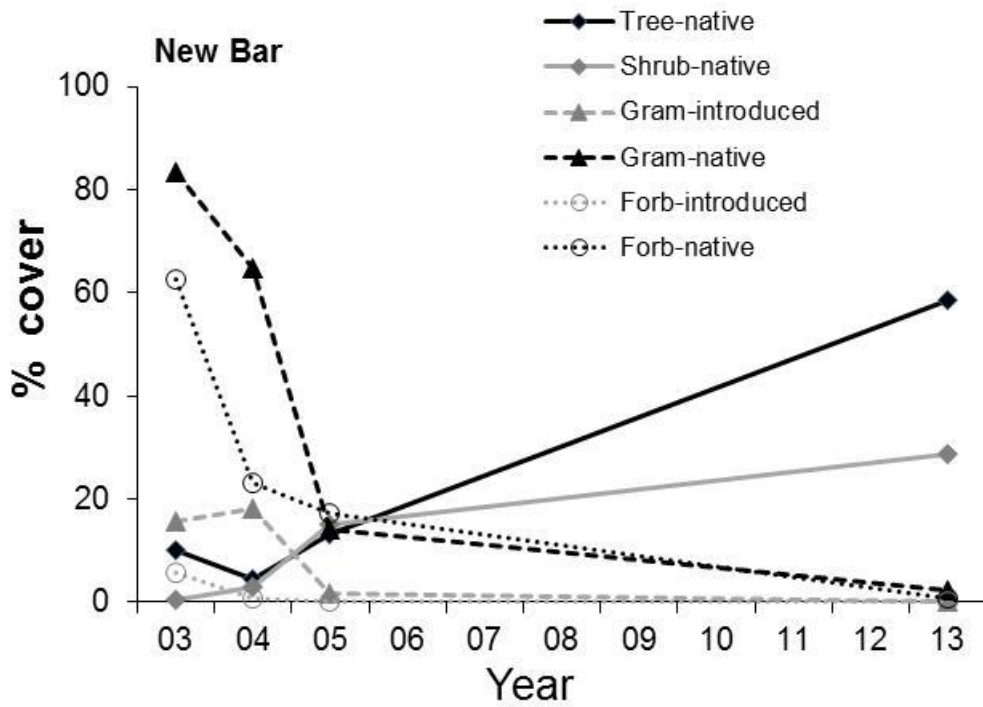
Figure 15. Canopy cover for trees, shrubs, graminoids (Gram), and forbs among natives and introduced species in the New Bar zone since 2003. 2003 is when the area began to develop perennial vegetation cover.

despite the greater number of native species. In contrast, on the New Bar, introduced species were particularly low in cover, but herbaceous cover declined overall as tree and shrub cover increased (Fig. 15). Regardless, even with declining abundance, forbs continued to account for 50% of the species richness, as they had in all years.
