# Double E Ranch Riparian Assessment

A Survey of Current Ecological Conditions  
to  
Support Resource Management Planning

Natural Heritage New Mexico Report – 15-GTR-390  
for  
New Mexico Department of Game and Fish

November 2015

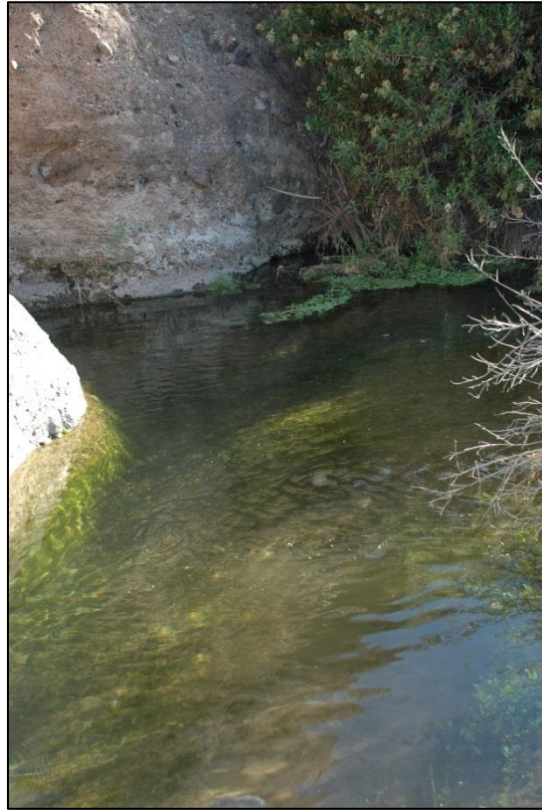
Figure 2. Scour pools are scattered within the canyon.

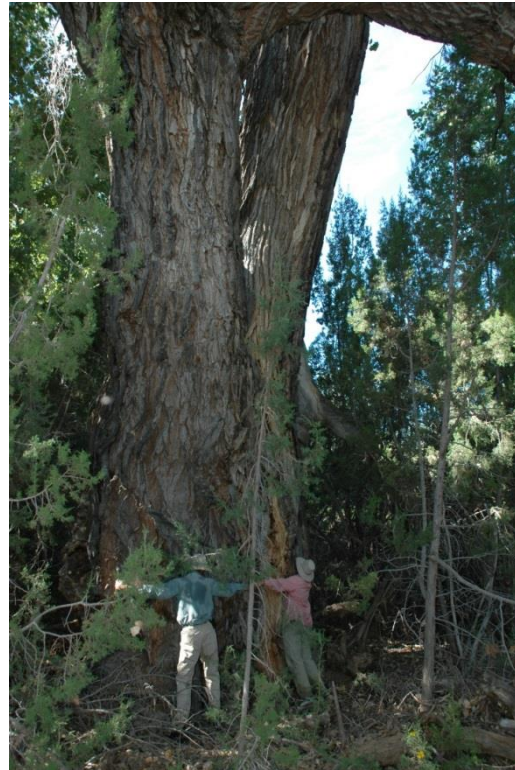
Figure 14. Very large Fremont's cottonwood in the Eastern SA, typical of scattered very large individuals throughout the canyon.

Small stands of globally rare and important riparian forest habitat types are scattered throughout the Bear Creek canyon on the Double E (see Figs. 11 to 13). While the size of these stands is limited by the narrowness of the canyon and the frequency of flood events, there are stands of both very large old trees and younger regeneration trees (see Fig. 11-13; Fig. 14). Shrublands throughout the ranch also tend to be small and patchy. While the frequency of large flood events likely plays a role, past livestock browsing and off-road vehicle traffic may have also reduced their extent. Accordingly, protecting the canyon from disturbance by livestock and off-road vehicles will allow shrub layers to reach the maximum extent possible within the physical and hydrological limitations of the canyon. Herbaceous wetlands were limited to communities dominated by water speedwell within the active channel and weedy (ruderal) communities on adjacent bars and terraces. The ruderal nature of the bar and terrace herbaceous communities may also be driven by flash-flood events through the narrow canyon. It was the prevalence of these ruderal herbaceous communities, often dominated or co-dominated by exotic species, that caused the Relative native plant community composition score for the ranch to be in the Good, rather than Excellent, category.
