# River Ranch Riparian Assessment

A Survey of Current Ecological Conditions  
to  
Support Resource Management Planning

Natural Heritage New Mexico Report – 15-GTR-388  
For  
New Mexico Department of Game and Fish

June 2015

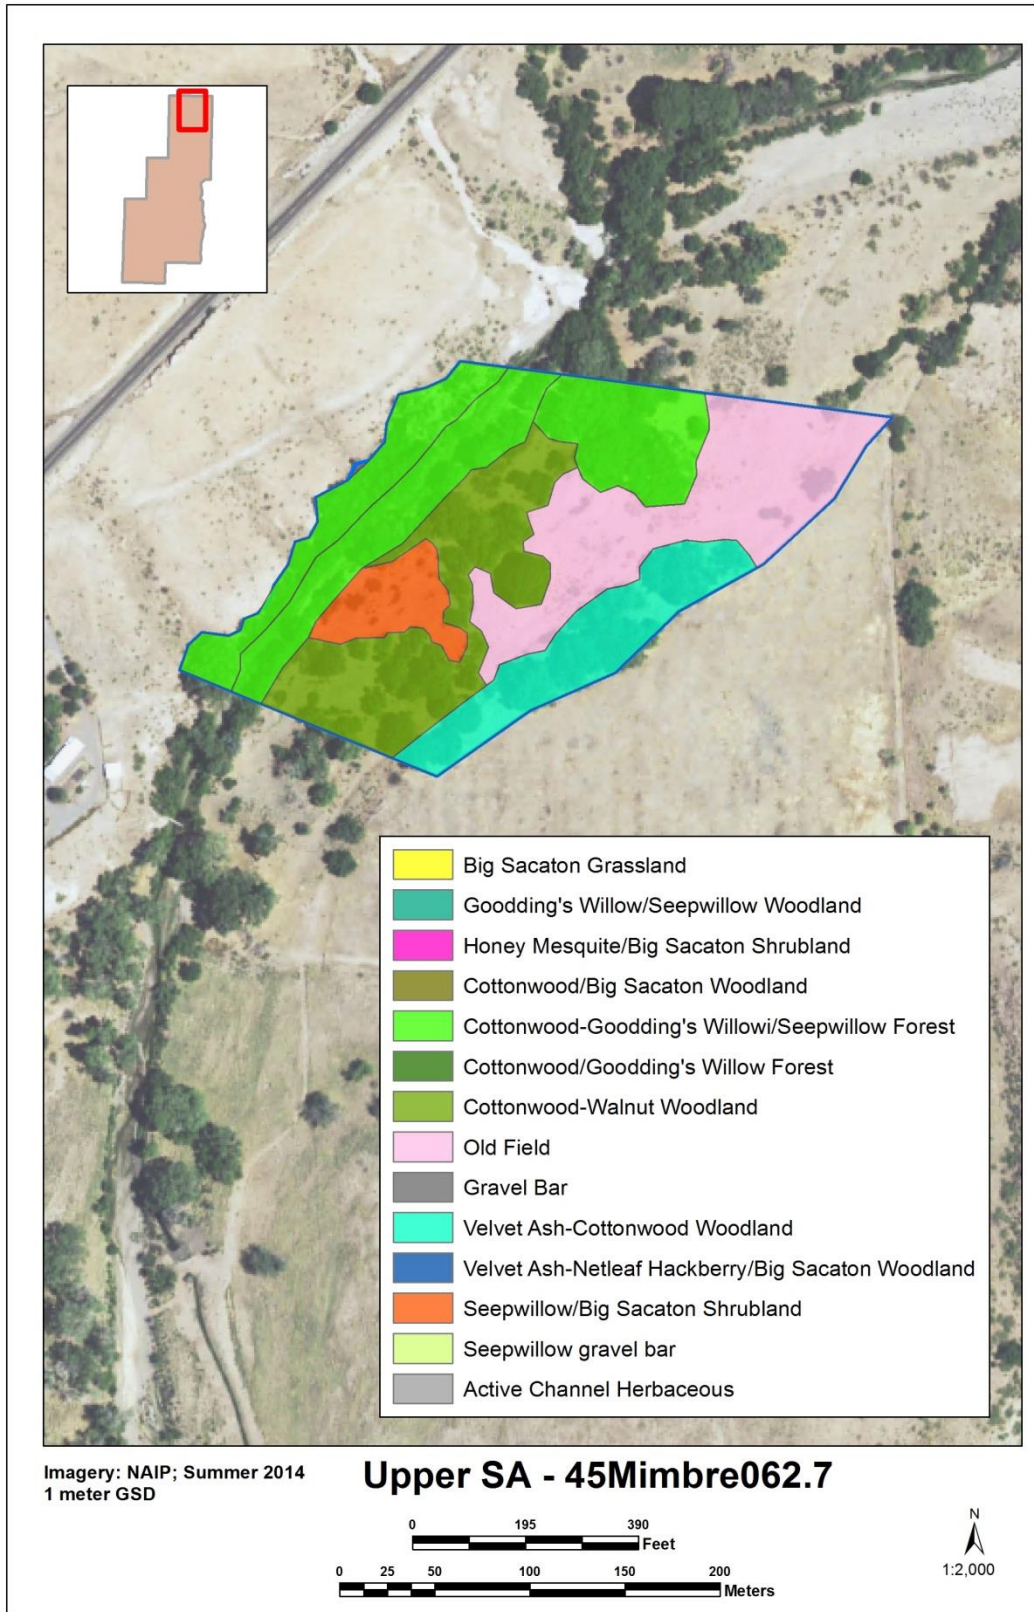
Figure 14. Vegetation Polygon Map for Upper SA - 45Mimbre062.7.

There were 14 different vegetation patches types mapped as part of the Biotic Metric data collection process (Figs. 14 to 16). These patches represent nine recognized plant communities, and four vegetation groups in the U.S. National Vegetation Classification<sup>10</sup> (Table 1). Although detailed community composition data was not collected as part of the NMRAM process, there is a wealth of published data available on the majority of the vegetation communities observed on the River Ranch. The ranch's forest communities dominated by Fremont's cottonwood, velvet ash and Goodding's willow are all considered globally rare and highly threatened due to altered hydrologic regimes, flood control structures, and land conversion.

Overall, the River Ranch supports high quality stands of globally rare and important riparian forest habitat (Figures 14 to 16). However, indications from the NMRAM assessment are that some of these forest stands are relatively old (125+ years), and young reproduction is absent. Most of the forest stands on the ranch consist of old mature trees, with minimal or no riparian shrub understory, which is reflected in the Poor Vertical Vegetation Structure score. Lack of a shrub layer suggests a lowered groundwater table that fails to support wetland obligate and facultative species such as coyote willow (*Salix exigua*) and seepwillow (*Baccharis salicifolia*) (Stromberg and Tiller 1996). Further vegetative indicators of a lowered groundwater table were seen in the upland or facultative herbaceous species, such as big sacaton that made up the forest herbaceous understories. Big sacaton, which tolerates deeper water tables than even mature riparian trees (Stromberg and Tiller 1996), also occurred as large nearly monotypic grasslands on the terraces in between the mature forest patches.
