New Mexico Rapid Assessment Method (NMRAM)

Riverine Wetlands

Stream Bank Stability and Cover

New Mexico Environment Department
Surface Water Quality Bureau
Wetlands Program

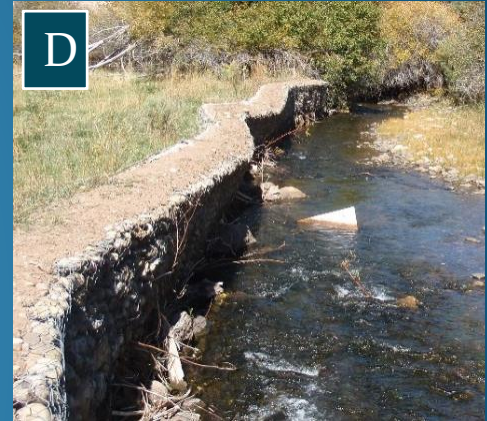
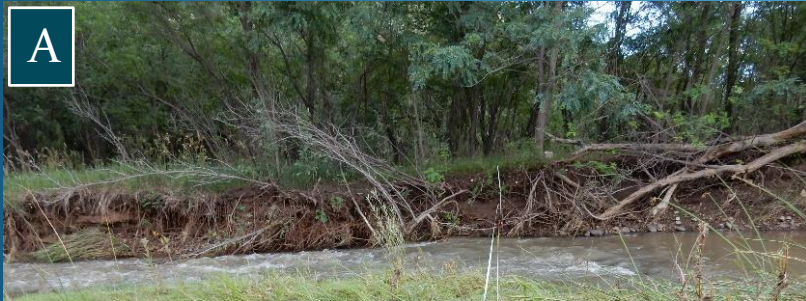
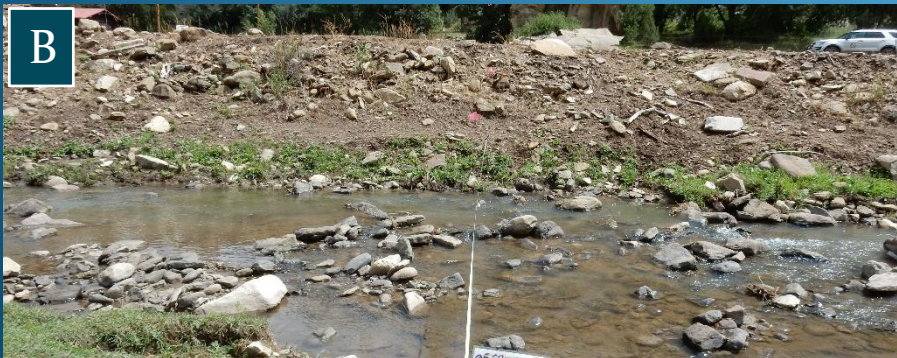
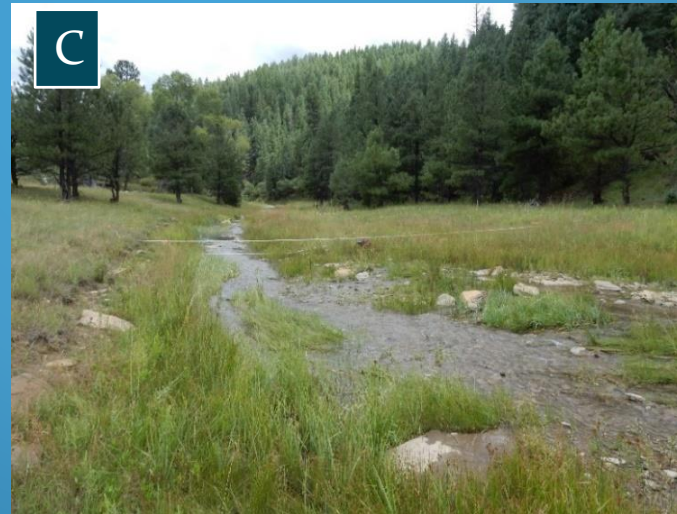
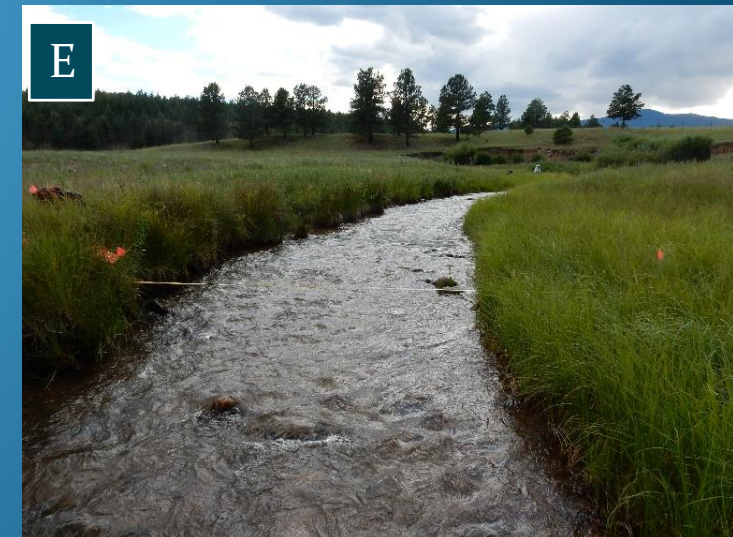
Bank Soil Stability

- Estimate % of bank with exposed soil
- Channel shape
- Artificial hardening rates “1”

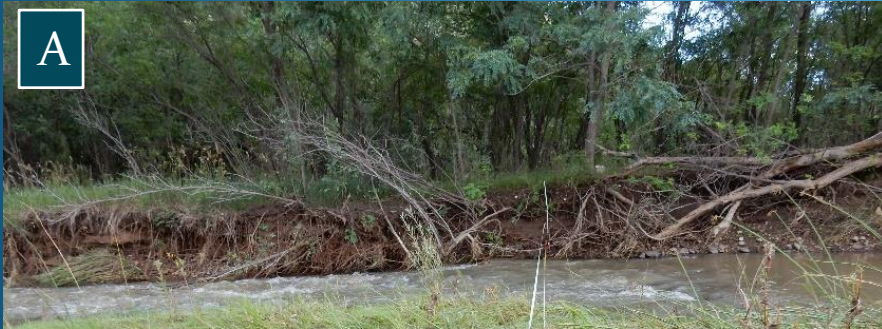
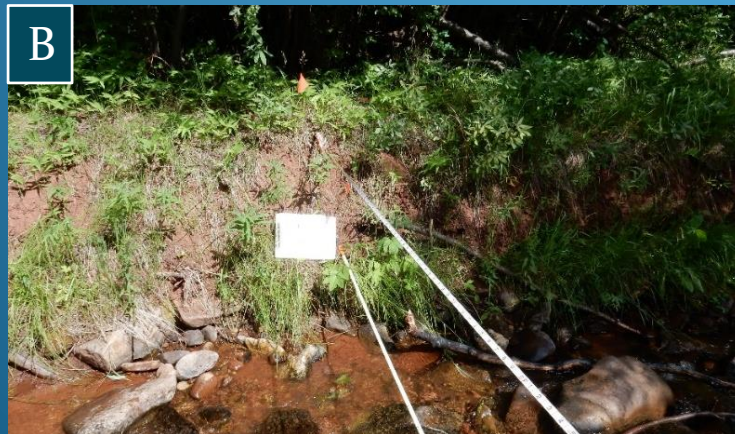
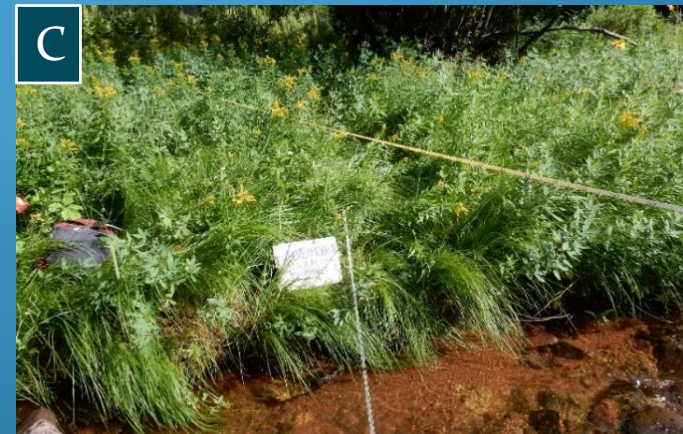
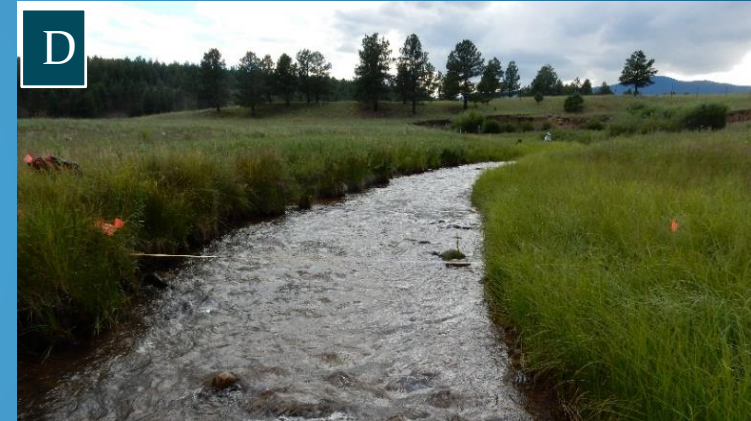
Stream Bank Erosion Potential

- Estimate % of bank with vigorous vegetation
- Cobble, other large material (natural)
- Artificial hardening still rates “1”

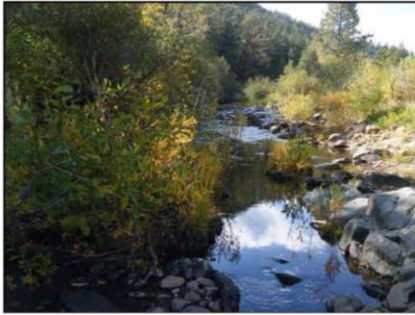
A) The stream banks here exhibit vigorous vegetative growth and large cobbles and boulders protecting the banks that would support a high Stream Bank Erosion Potential. In addition, little soil is exposed, supporting a high Bank Soil Stability rating.

Figure A4a. Examples of stream bank soil stability and erosion potential conditions.

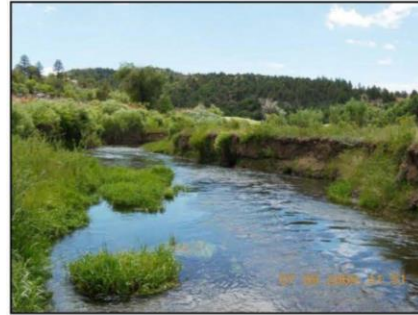
B) These banks display vigorous vegetation but also raw banks, slumping and exposed soils. The stream is unstable and overwide, leading to a lower rating.

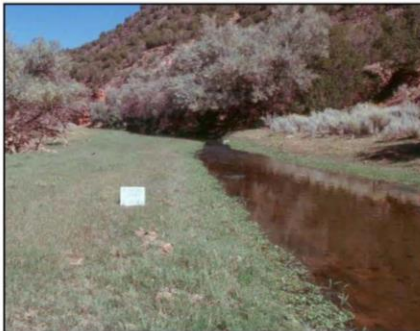
C) Due to bank trampling and grazing, this stream channel has a flattened stream bank, which would rate a 1 for bank stability. Hoof punching is affecting the vegetation continuity as indicated by the exposed soil on between 25 and 50% of the bank surface, leading to a 2 rating for Stream Bank Erosion Potential.

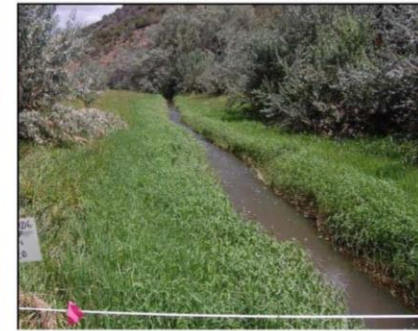
D) This image was taken in approximately the same location as Figure C but after grazing and trampling had been removed for several years. The banks have been able to regain a more stable profile, and the banks are covered with vigorous wetland vegetation. The site would now rate a 4 for Stream Bank Erosion Potential and a 3 for Bank Soil Stability.
