## New Mexico Rapid Assessment Method (NMRAM)

### *Riverine Wetlands*

# Score Roll-Up

# NMRAM Riverine Assessment Wrap Up

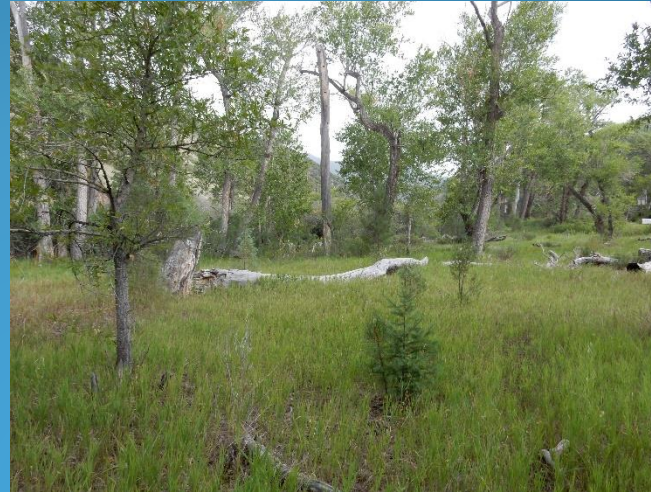
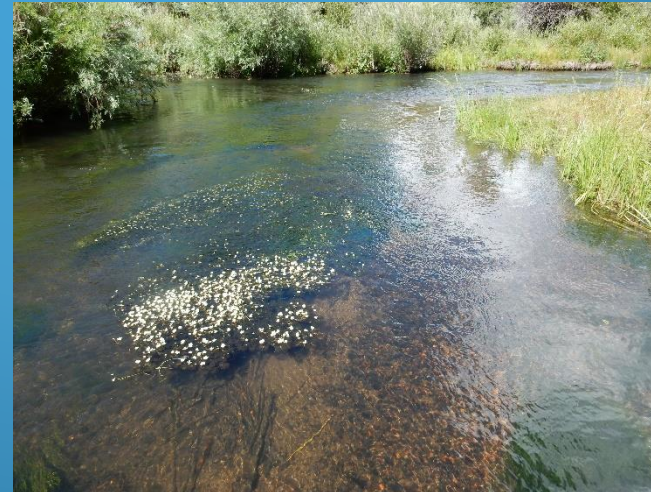
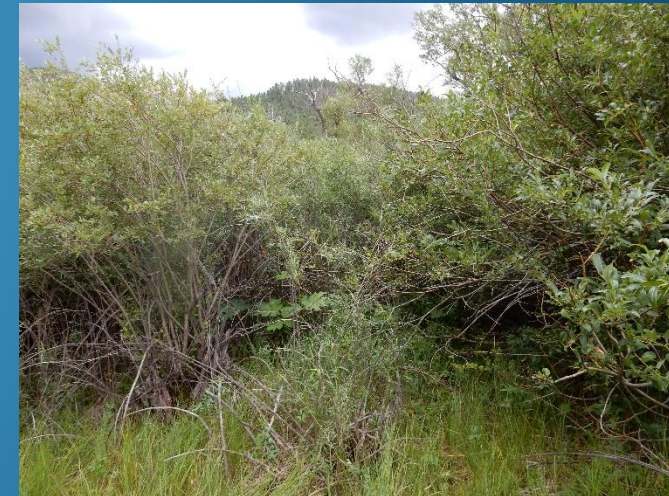
Stressor Summary	Major	Minor	Top Three
	1	6	1 Agriculture/Urban flow diversion upstream
			2 Excessive noise affecting wildlife
			3 Adverse sediment retention by dams

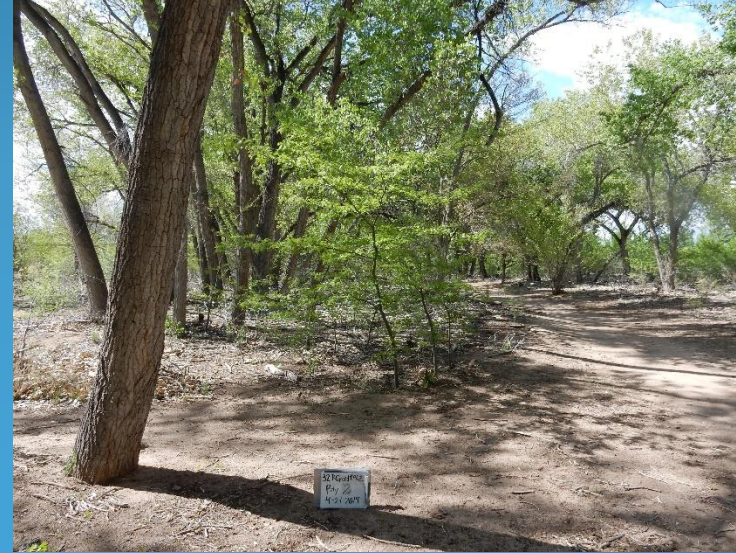
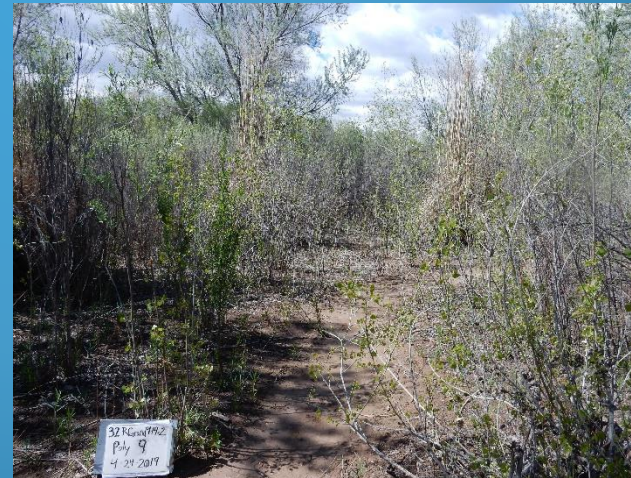
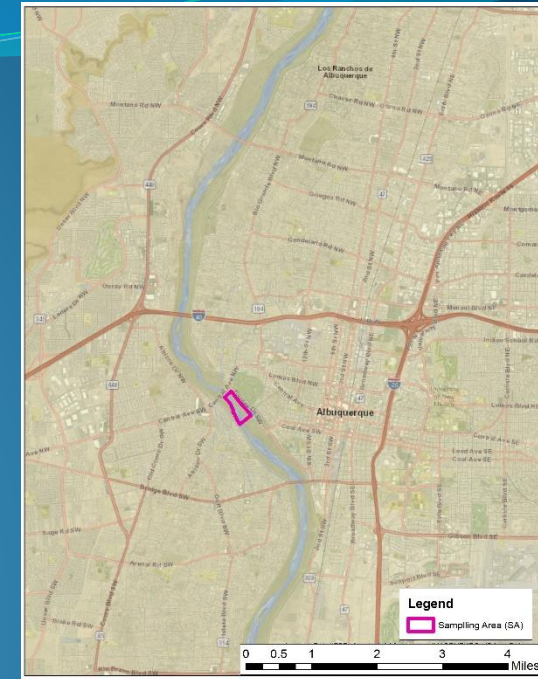
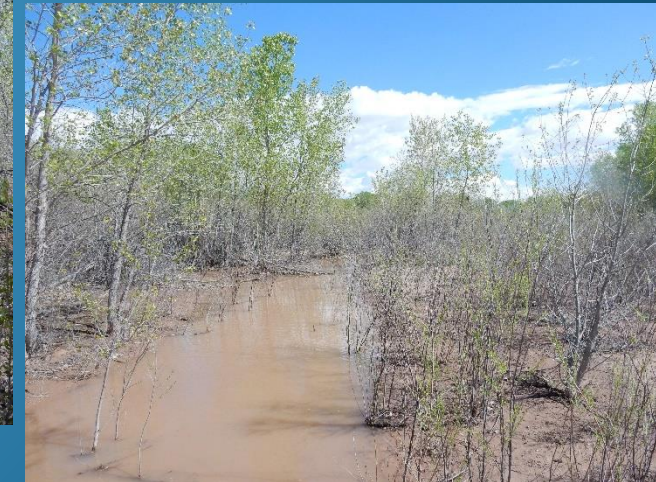
# Score Roll-Up – Lowland example

**SA CODE:** 32RGrand474.2

Stressor Summary	Major	Minor	Top Three
	9	3	
			1 Extended low flow dam releases
			2 Timing of flow releases not concordant
			3 Adverse sediment retention by dams
